**Property Information**

Belvidere Old Town District

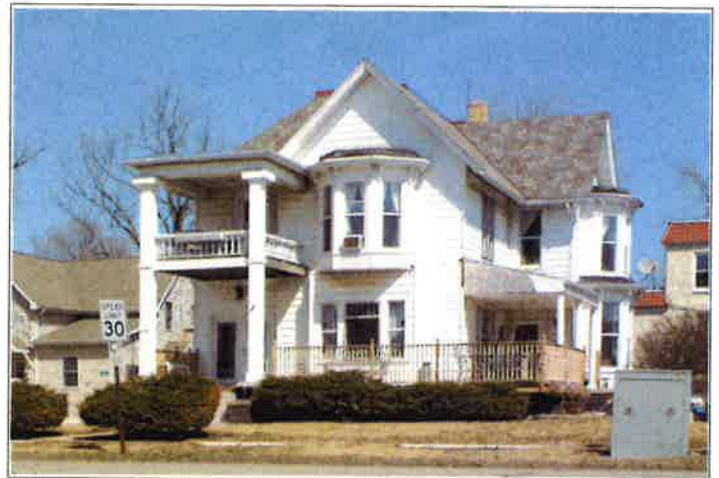
Photo: 405\_N\_State\_St\_SURVEY\_Photo.tif

The Queen Anne, single family frame house is two-and-one-half stories with a steeply pitched hipped roof and cross-gabled massing. The first floor is raised on a foundation of coursed limestone, the exterior is clad in siding, and the brick chimney is centrally located on the hipped roof. The primary elevation, facing west, is asymmetrical with a gable-front section extending slightly forward of a two story hipped-roof section at the northwest corner. The cross gables face north and south, with a gabled rear wing to the east. At the west elevation there is a brick veranda with a simple wooden railing. Starting at the primary entrance, it wraps around to the south side entrance. Over the main entrance door at the northwest corner, two large, square, wood columns support a second floor deck and flat roof. The pair of unoriginal entrance doors have full height lites, and an unoriginal single leaf lighted and paneled door leads onto the deck above. Under the west gable is a centered window bay. Originally two stories tall, the first floor bay has been partially removed and infilled with a landscape window flanked by two double hung windows. Above, the second floor section of the original three-sided bay retains shaped windows heads...

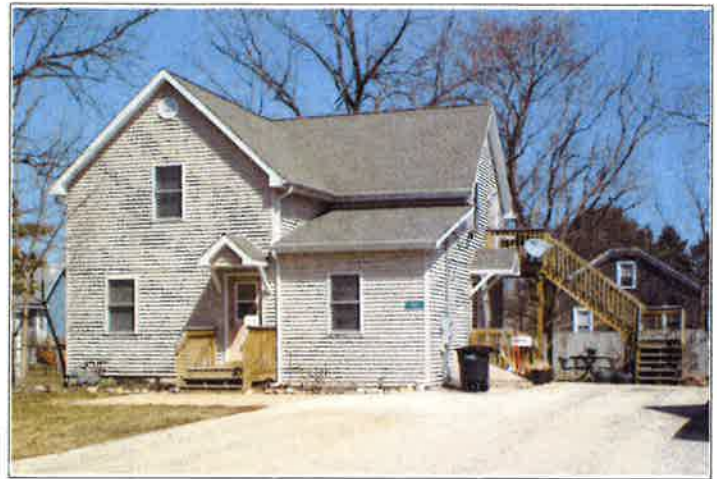
Photo: 411\_N\_State\_St\_SURVEY\_Photo.tif

The multi-unit house is two stories with a steeply pitched gable roof and "L" shaped plan. The first floor sits on a brick and parged foundation, the exterior is clad in siding, and roof has asphalt shingles. The primary gable faces west with a single leaf entrance door situated at a wood deck under a small gabled portico. Two double hung windows at the first and second floors are balanced on the façade. At the southwest inner corner of the "L" shaped plan, a one story section is enclosed under a shed roof with a single west-facing window. At the south elevation there is an additional entrance door and porch with similar details to the west entrance. A flight of wood stairs leads to a second floor entrance at the south elevation gable, which is centered with an adjacent window. The single 1/1 double hung windows have rectangular sash. A cellar door leading to the basement level is situated at the southwest corner.

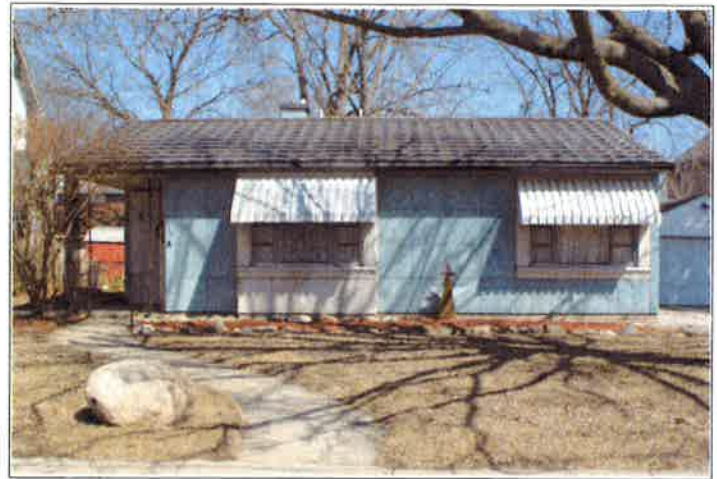
Photo: 415\_N\_State\_St\_SURVEY\_Photo.tif

This Lustron, single family home is one story tall with a low-pitched, side-gabled main section with rectangular massing and central chimney stack. It has a concrete foundation with rectangular porcelain-enameled wall panels of "Surf Blue" colored Lustron. The gable ends, projecting to form shallow eaves, are clad in vertical porcelain-enameled panels. The shingle-style roof tiles, gutters and eaves are also porcelain-enameled. The main entrance, a single leaf lighted door, is recessed at the northwest corner with one simple "zig-zag" metal support. The main façade, facing west, has two large metal window assemblies, each composed of a large picture window flanked by 4-lite casements. The centered window grouping is set in a shallow projecting bay of ivory colored enameled tile. This signature feature was only available on the "Westchester Deluxe" Lustron model. The three-window grouping also appears next to the entrance on the north façade. Along the south façade, two pairs of 3-lite metal casements are placed symmetrically. The window headers are accentuated with a simple rolled panel. A frame, one-car garage clad in siding is situated at the southeast corner of the house. ...

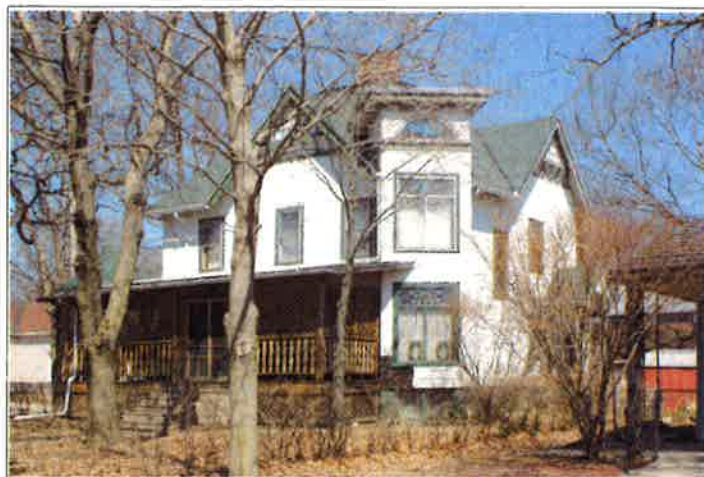
Photo: 421\_N\_State\_St\_SURVEY\_Photo.tif

The Queen Anne, single family frame house is two-and-one-half stories with a steeply pitched hipped roof, cross-gabled massing and corner tower. The first floor is raised on a parged masonry foundation and the exterior is clad in unoriginal siding. The primary elevation, facing west, is asymmetrical. Centered on the two-story hipped-roof body are an open front gable and three window bays at each floor. A two-and-one-half square tower is engaged at the southwest corner. Open cross gables face north and south, and a brick chimney rises from the center of the flattened hipped roof apex. A two story gabled rear wing extends to the east. The south elevation windows are staggered with some stained glass, suggesting a proximity to an interior staircase. Windows on the north elevation and east wing are placed asymmetrically. The square corner tower has a flat roof, but historic photographs show a high double-pitched hipped roof and decorative finial, with additional cresting along the main roof ridges. At the tower's first and second floor, windows wrap the three sides with large landscape windows and stained glass transoms at the face. At the tower's attic level there is broad half-round window. The original front and...

...side porches have been replaced. Historic photographs show porches with elaborate spindlework, short mansard roofs, bracketing, latticework and decorative balusters. The existing front porch has an asphalt shed roof with a faceted turret roof at the northwest corner. The porch is enclosed with simple wood lattice and a sawn balustrade. To the south is a side entrance stoop of rock-faced block and a gabled portico roof. The existing single leaf entrance door, which replaced the original pair flanked by sidelights, is centered under the west gable. The original single 1/1 double hung wood windows, shorter at the second floor, have rectangular sash with simple wood framing. Small rectangular 1-lite basement windows pierce the foundation and a few short 1/1 windows are placed on the rear wing. Most openings have aluminum storm windows or doors installed. Historic photographs show elaborate detailing, some of which remains. The gables have decorative verge boards and the three main gable tops have a triangular, latticed section that projects forward and is supported by brackets. Scallop and dart wood shingles remain towards the top of the tower. A mid 20th century frame two-car garage with gabled roof is sited to the east near the rear elevation. Built to a large scale with great attention to detail and installation of decorative elements, this house was originally a fine example of the Spindlework sub-type of the Queen Anne style. Though the original massing is still intact, the extensive removal of decorative elements has compromised its integrity.

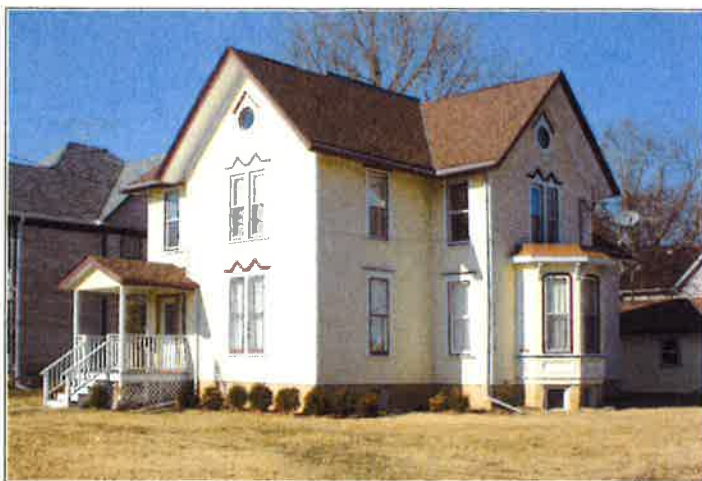
Photo: 505\_N\_State\_St\_SURVEY\_Photo.tif

The Queen Anne, single family frame house is two-and-one-half stories with a steeply pitched hipped roof and cross-gabled massing. The first floor is raised on a foundation of coursed limestone, the exterior is clad wood clapboards and corner boards, and the brick chimney is centrally located towards the back of the hipped roof. The primary elevation, facing west, is asymmetrical with a gable-front section extending slightly forward of a two story hipped-roof section at the northwest corner. The cross gables face north and south, with a gabled rear wing to the east. At the northwest corner there is the front entrance with a wood stoop and gabled portico supported by simple wood posts and a simple railing. The original entrance door has been replaced with a modern single leaf lited door and sidelight. Centered under the west gable are pairs of double-hung windows at the first and second floors. Above, small round attic windows sit high in the gable. The north elevation gable end has the same arrangement. The south gable end has a centered one story window bay with a limestone foundation, paneled spandrels, shaped window heads, decorative cornice brackets and a short, flared mansard roof. ...

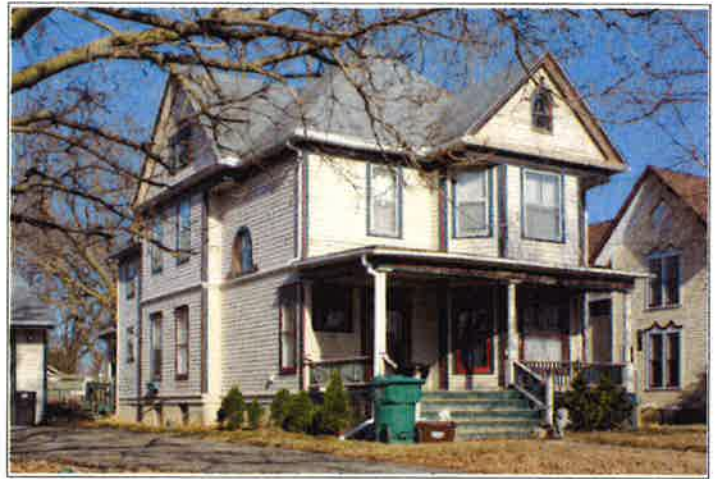
Photo: 507\_N\_State\_St\_SURVEY\_Photo.tif

The Queen Anne, single family frame house is two-and-one-half stories with a steeply pitched hipped roof with lower cross gables, giving each façade an asymmetrical appearance. The first floor is raised on a parged masonry foundation and the exterior is clad in wood clapboard. At the primary elevation, facing west, a gable-front section extends slightly forward from the hipped-roof section at the northwest corner. Below the third floor closed gable, the first and second floors form a canted window bay. Stretching the entire width of the principle façade is a one story porch with slender turned colonnettes, a simple wood railing, and a flat roof. The entrance door is paneled and has a multi-lite storm door, with a decorative Queen Anne diamond-lite sash situated beside it. The north and south gables are also closed at the third floor; the floors below are slightly shorter in width, leaving the third floor to overhang in one corner or another. Windows are placed symmetrically on the overall asymmetrical elements. The rear wing, extending to the east, is gabled. The detailing is typical of Free Classical Queen Anne homes. The single, tall, double-hung 1/1 windows have rectangular sash with simple, classically inspired...

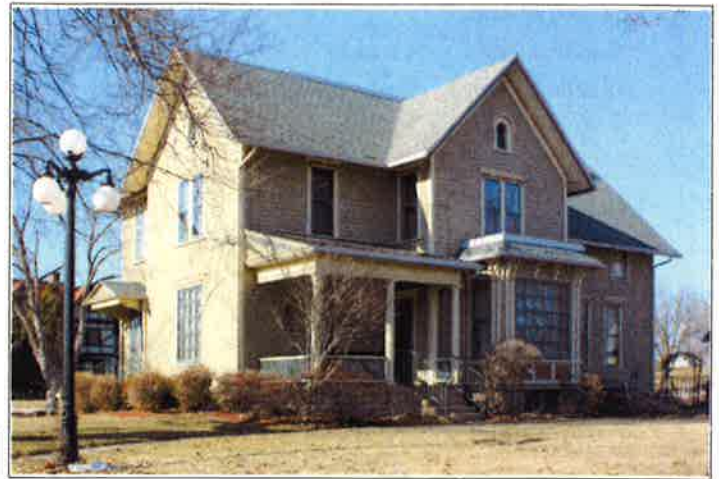
Photo: 521\_N\_State\_St\_SURVEY\_Photo.tif

The Queen Anne, single family frame house is two-and-one-half stories with a steeply pitched hipped roof and cross-gabled massing. The first floor is raised on a parged masonry foundation and the exterior is clad in wood clapboard. The primary elevation, facing west, is asymmetrical. A gable-front section with centered window openings extends slightly forward of a two story hipped-roof section at the northwest corner. Here there is a cement stoop with a simple iron railing and a gabled portico supported by plain brackets. The pair of entrance doors are paneled with three high lites. To the south is a side entrance door and porch with a shed roof and simple turned, tapered columns. The south elevation gable end windows are also centered. At the first floor there is large window bay of double-hung and multi-lite windows over a paneled spandrel, and a bracketed cornice with a short mansard roof. The north gable end elevation is typical with symmetrical window openings. The rear wing, extending to the east, has asymmetrical window placement along the north and south elevations. At the east gable end, the windows and a small one-story enclosed entrance porch, with a bracketed cornice and short mansard roof, are...

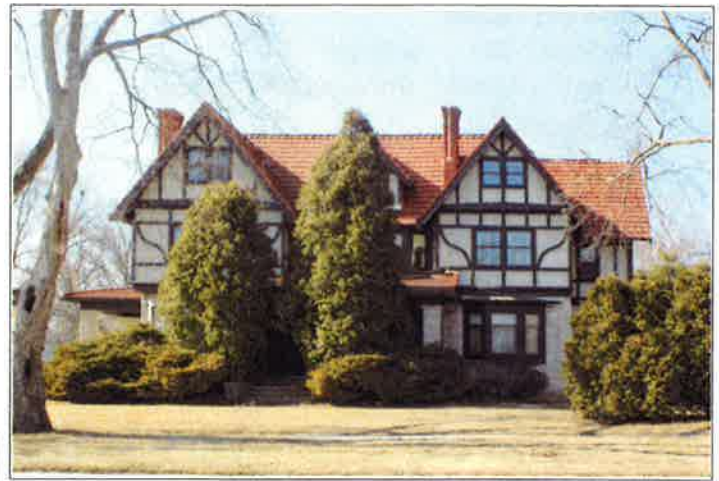
Photo: 605\_N\_State\_St\_SURVEY\_Photo.tif

The Tudor Revival, single family house is three stories with large central massing and a shallow U-shaped plan. Its tall, steeply pitched clay tile roof is picturesque and irregular with multiple prominent gables and dormers. On a slightly graded site, the first level is clad with a random course, rusticated stone veneer. The second and third levels are clad in decorative half-timbers and stucco. The primary elevation, facing south, is nearly symmetrical; two large full-height front gables project out from the central massing. Below each, shallow bays of stone and wood project at the first level while the third level overhangs the second. A wide, one-story shed roof of clay tile is supported by stone veneered posts and extends out between to partially cover a screened veranda. Above is a shallow bay, placed asymmetrically at the second floor, a third floor gabled dormer, and a tall decorated chimney stack. The veranda, bordered by a short concrete baluster, continues around to a side entrance on the west façade which is located under a hipped roof porch with stone veneer corner posts. The west elevation also features an imposing, decorated chimney stack with stone accents and a projecting, off-center gable. A shallow bay at...

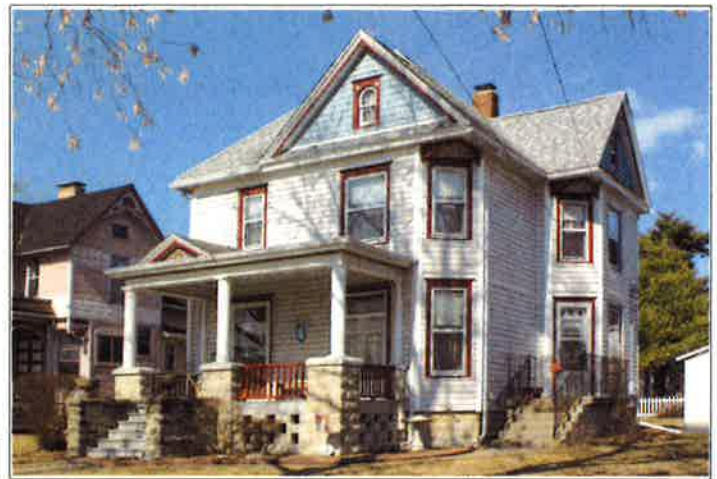
Photo: 615\_N\_State\_St\_SURVEY\_Photo.tif

The Queen Anne, single family frame house is two-and-one-half stories with a steeply pitched hipped roof with lower cross gables, giving each façade an asymmetrical appearance. The first floor is raised on a foundation of dressed, rusticated limestone and the exterior is clad in siding with scalloped wood shingles in the gable pediments. At the front façade, facing west, is a prominent pented gable with two window bays at the first and second floors. At the southwest corner, a canted window bay leaves and the gable to overhang, a detail which is accentuated with decorative brackets. Stretching the entire width of the principle façade is a one story porch. The original groupings of slender turned colonnettes have been replaced with fluted columns, though two pilasters remain. These columns are set on pedestals of the same foundation stone and arrangement, with additional blocks used to screen the porch base and as knee walls along the steps. The porch has a simple wood railing, dentils and a shallow hipped roof accented with a pediment over the entry. The wide entrance door is paneled with a half lite and a landscape window with a beveled glass transom is situated at the front façade as well. The north and...

...south gables are also pented at the third floor. Below the south gable, a side entrance door is located on the two story canted window bay. Historic photographs show a side porch here, detailed to match the front porch. Now removed, the side door is accessed from a concrete stoop with a simple iron railing. Next to the side entrance, another landscape window is placed on the south face of the bay. The one-and-one half story rear wing with gabled roof extends to the east. A small one story addition at the northeast corner has a concrete foundation and shed roof. The single, tall, double-hung 1/1 windows have rectangular sash with simple, classically inspired wood framing. The first floor windows are taller than the second, and small rectangular 1-lite basement windows pierce the foundation. On the front façade, a small, double-hung arch-top attic window sits high in the gable pediment, framed with rectangular wood trim and roundels. In the north and south gable pediments are small, square-top double-hung windows with simple trim. Most openings have aluminum storm windows installed. The detailing is typical of Free Classical Queen Anne homes.
