**Property Information**

Address: 222 N Main PIN: 05-26-431-014  
 Building Names:  
 Important Dates:  
 Historic Function: Residence  
 Current Function: Residence  
 Color Code Criteria: None  
 Outbuildings  
 Number: 0 Any Significant:   
 Architectural Style: Colonial Revival  
 Property Type: Residential  
 Approximate Age: 1900-1909  
 Condition: Heavily Altered  
 Potential for Integrity?

Individual Eligibility   
 District Eligibility:   
 District Name:  
 Belvidere Old Town District

Individual Eligibility:   
 District Eligibility:   
 District Name:  
 Belvidere Courthouse Square  
 Local Historic District

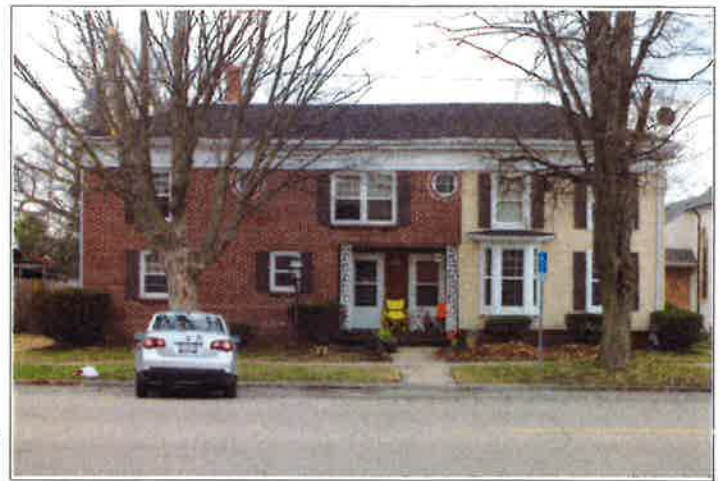
Photo: 222\_N\_Main\_St\_SURVEY\_Photo.tif

The duplex building is two stories tall with a hipped roof and a rectangular plan. The main massing spans six bays wide by two bays deep. The south four bays are constructed of red brick and the north two bays have a parged foundation and frame construction. At the shallow eaves, the two sections are tied together with a wide cornice board. One brick chimney is located near the north wall, and another is situated near the ridge hip to the south. The front façade, facing east, is asymmetrical around a central recessed entry porch. Two decorative cast metal supports flank the opening, and inside the recess, which is clad in siding, there are two slab entrance doors. Typical windows on the brick section are pairs of 9/9 replacement double-hungs with square tops, faux shutters and brick sills. Two small round windows, now filled with 6 lite square sash, are located at the second floor and one small 1/1 double hung window is adjacent to the central entry porch. Typical windows on the frame section are single 6/6 double hung replacements with square tops, clad frames and faux shutters. A three-sided bay window with hipped roof and multi-lite sash is located adjacent to the central entry porch. Small additions at the rear are...

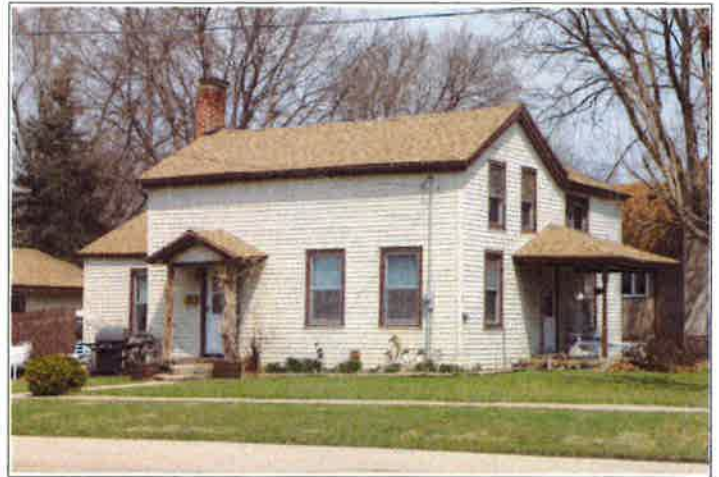
Photo: 305\_N\_Main\_St\_SURVEY\_Photo.tif

The single family dwelling is two stories tall with upright and wing massing and a gabled roof. The upright massing spans two bays wide by three bays deep, and the wing spans one bay wide by two bays deep. The foundation is not visible and the walls are clad in vinyl siding. A brick chimney is located on center at the north gable end wall. The front façade, facing south, has asymmetrical window placement around a central entry porch. Here, a low concrete stoop and turned wood columns support a hipped porch roof. The single leaf entry door is a replacement. Original window openings are taller at the first floor, and the original windows have been replaced with 1/1 double-hungs with clad frames. Along the west elevation there are two first floor windows and a side entrance at the northwest corner. Similar to the front porch, the side porch has a small gabled roof. At the rear, a small one story gable roof addition is clad in siding. Set at the northwest corner of the lot there is a modern two-car garage with a gabled roof clad in siding. The massing, size and arrangement of feature suggest that this was constructed in the settlement era. However, the integrity of this early structure has been compromised and many elements have been altered.

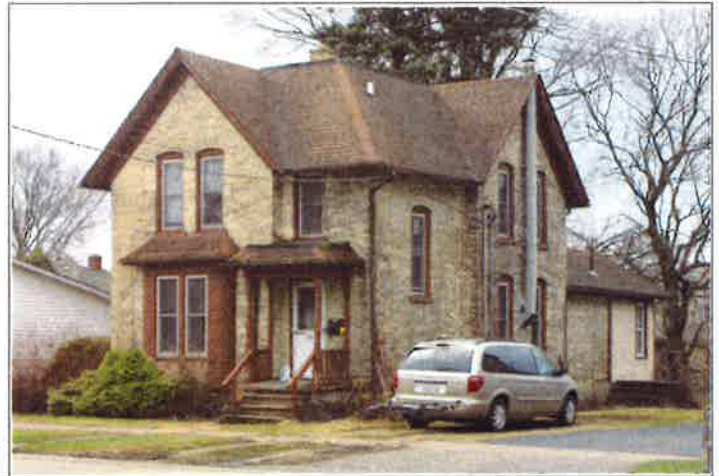
Photo: 310\_N\_Main\_St\_SURVEY\_Photo.tif

The Queen Anne, single family brick house is two stories with a steeply pitched hipped and cross-gabled roof and massing. The first floor is raised on a coursed limestone foundation with a dressed-stone water table and the walls are constructed of cream colored brick laid in a running bond. The internal brick chimney is centrally located on the hipped roof. The primary façade, facing east, is asymmetrical with a prominent front gable and the main entrance is located at the northeast corner. Window openings are centered under the gable: two windows at the second floor and a bay at the first floor. The bay contains two windows and is shallow with curved corners clad in scalloped shingles. The bay roof is hipped to meet the second floor window sills. The main entrance is located at a small concrete stoop with a simple railing, turned wood columns and a short, flat mansard roof. Set back one window bay, the south and north projecting cross gable elevations have symmetrical façades with two centered windows. The original brick rear wing, extending to the west, is one story tall with a gabled roof. A small enclosed porch and addition were added around the rear wing. The tall, narrow 1/1 windows have rectangular sash with segmental-arch...

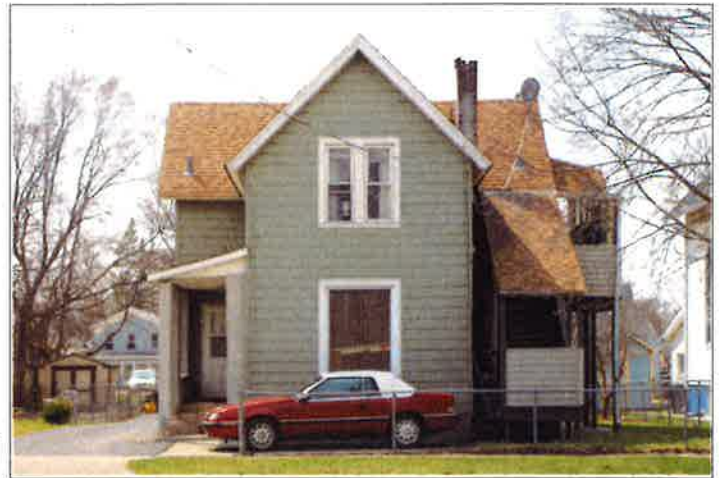
Photo: 316\_N\_Main\_St\_SURVEY\_Photo.tif

The Queen Anne, multi-unit dwelling is two stories with a steeply pitched cross-gabled roof and "T" shaped plan. The first floor is raised on parged foundation and the walls are clad in replacement siding. A brick chimney is located on the inside corner of the north elevation. The primary façade, facing east, is symmetrical with a prominent front gable and centered window openings. The main entrance is located at the southeast inside corner off a modified shed roof porch. Window openings are centered under the front gable with a pair of double hung windows at the second floor and a large plate glass window at the first floor. Set back one window bay, the south and north projecting cross gable elevations have symmetrical façades with two centered windows. However, a covered wood stairway leading to the second floor was added at the north elevation and obstructs most of that façade's features. A rear wing, extending to the west, is one story tall with a gabled roof. The tall, narrow 1/1 windows have rectangular sash and clad frames, and small rectangular basement windows pierce the foundation. All original windows have been replaced. Though little to no detailing remains, this dwelling likely had a Queen Anne style. However...

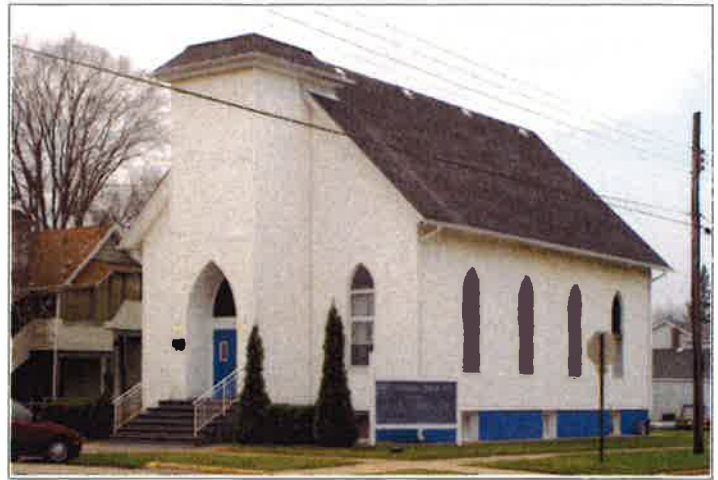
Photo: 320\_N\_Main\_St\_SURVEY\_Photo.tif

The Carpenter Gothic style center steep church has a steeply pitched gabled roof and rectangular plan with massing three bays wide by four bays deep. The main floor level is raised on a parged masonry foundation and the walls are clad in siding. The primary façade, facing east, is symmetrical with a projecting tower flanked by lancet windows. The original decorative tower lantern, seen in historic photographs, has been removed. A low-pitched overhang and flat roof, sitting level with the gable ridge, remains but is missing decorative brackets. At the base of the tower, a pair of unoriginal entrance doors and a modified transom are recessed in a pointed arch opening. Above the entrance, a tall lancet window has been covered up or removed. Along the south, east and north elevations, the original lancet openings remain, though they have been modified with fixed tops and short double-hungs. The original windows were 4/4 double hungs with shutters. At the west façade, two brick chimneys flank a three-sided alter bay with a hipped roof. Two wood lancet windows set with opalescent art glass remain. A small one story entrance addition at the southwest corner is sided and has a shed roof. Small rectangular windows pierce the foundation. While...

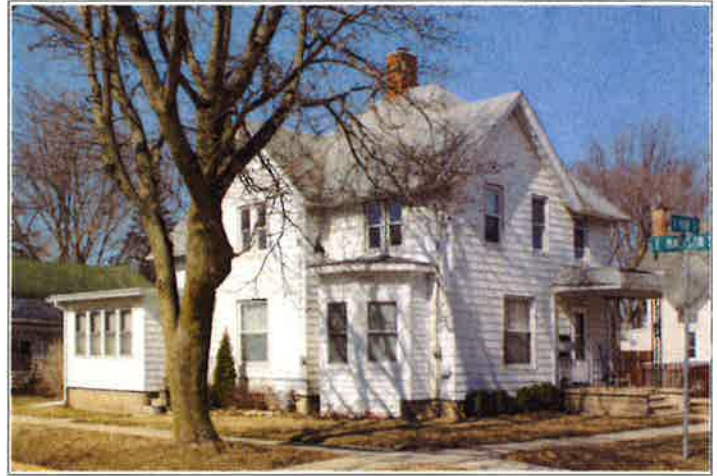
Photo: 404\_N\_Main\_St\_SURVEY\_Photo.tif

The Queen Anne, single family frame house is two stories tall with a steeply pitched hipped roof with cross gables, giving each façade an asymmetrical appearance. The first floor is raised on a parged masonry foundation, the exterior is clad in siding, and the internal brick chimney is centered on the hipped roof. At the front façade, facing east, there is a prominent open gable with off-center windows at the first and second floors. A small front entrance porch is situated at the northeast corner. Simple metal trellis posts support a short, flat mansard porch roof and rock-faced concrete blocks form the stoop. The single-leaf entrance door has been replaced. The north and south cross gables have centered windows and a one-story three-sided window bay is located on the south façade. The one-and-one-half story rear wing with gabled roof extends to the west. A small one-story enclosed porch at the southwest corner has a rock-faced concrete foundation and a flat roof. An original flat roof rear porch at the northwest corner has been enclosed. The double-hung 1/1 windows have rectangular sash with clad framing. Windows are paired at the second floor, with two wide windows at the first floor's front...

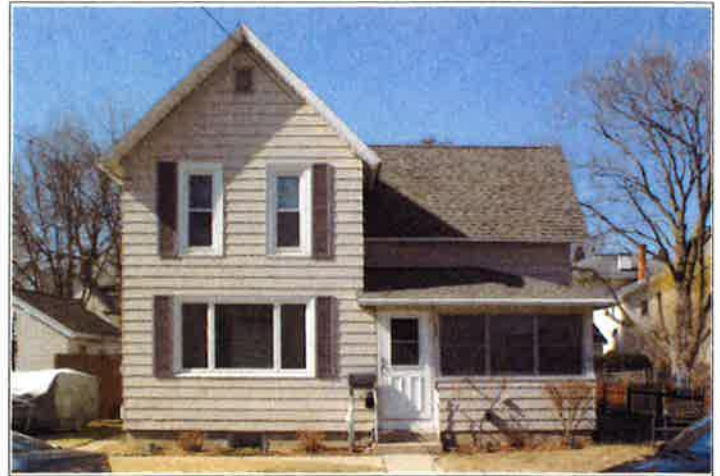
Photo: 408\_N\_Main\_St\_SURVEY\_Photo.tif

The two story residence has an Upright-and-wing form with a t-shaped footprint. The first floor is raised on a foundation of parged masonry and is clad in contemporary vinyl siding. The main front gabled massing, facing east, is two bays wide and deep with symmetrical window arrangement. A large, unoriginal tripartite window is located at the first floor and two 1/1 double-hung windows are at the second floor. The side gable wing is one-and-one half stories tall and is two bays wide by one bay deep. At the wing there is an enclosed front porch with a hipped roof. The window framing is clad and the original windows have been replaced with 1/1 double hung windows and a few faux shutters. A few small 1-lite windows pierce the foundation. At the northwest corner there is a small, one story gable and shed roof addition. The plan arrangement and height suggest that this is an example of a very popular 19th century Midwest farmhouse type. However, several elements have been replaced or altered, compromising the dwelling's integrity.

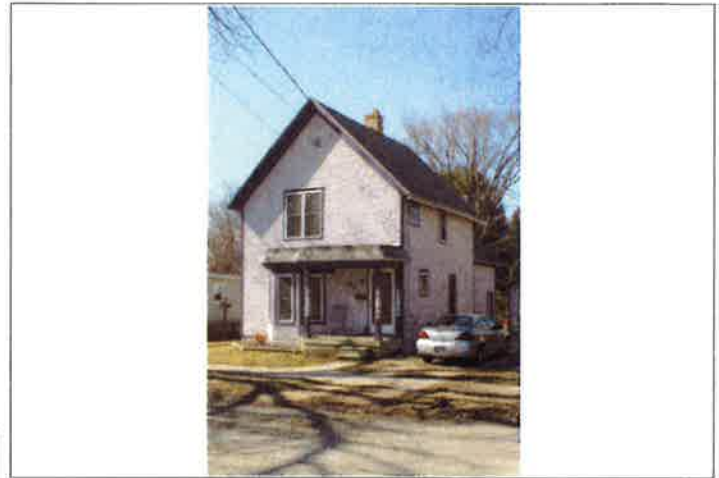
Photo: 412\_N\_Main\_St\_SURVEY\_Photo.tif

The single family frame Victorian cottage is two stories with a steeply pitched roof and front gabled massing. The first floor is raised on a low parged foundation and the exterior is clad in wood clapboards. The primary elevation, facing east, has an asymmetrical arrangement of features that reflects its expanded side-hall plan, and the internal chimney is centrally located. To one side, the wood front porch has a short, mansard, flat roof which is supported by turned columns and an unoriginal enclosed base. The single-leaf entrance door has been replaced with a paneled and oval lited sash. Adjacent to the front entrance and porch, a three-sided window bay is located off-center on the façade. The bay's short mansard roof merges with the porch roof to form an irregular connection. Two second floor windows are located directly above the off-center first floor windows with a louvered wood attic vent located on center in the gable end. The windows have simple wood framing, and most of the original windows have been replaced with 1/1 vinyl double hungs. The south and north elevation windows are spaced evenly or nearly on center with two small 1-lite windows along the north elevation around the interior stair hall. Second...

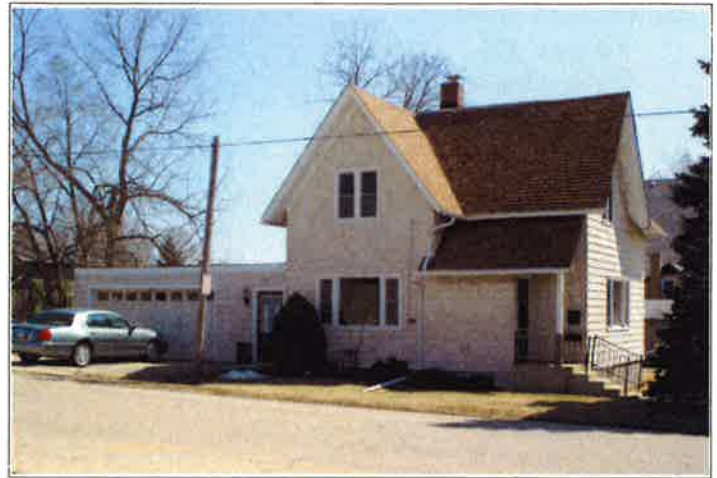
Photo: 423\_N\_Main\_St\_SURVEY\_Photo.tif

The single family frame cottage is two stories tall with a steeply pitched hipped roof with ell gables, giving each façade an asymmetrical appearance. The first floor is raised on a parged masonry foundation, the exterior is clad in siding, and the internal brick chimney is centered on the hipped roof. At the front façade, facing west, there is a prominent open gable with an unoriginal Chicago type window placed off center. At the second floor, a pair of double-hung windows is centered in the gable. A small front entrance porch is situated at the northwest corner. The original porch has been partially enclosed and heavily modified to include a shed roof, concrete stoop, and metal railings. The single-leaf entrance door is unoriginal. The north gable has a centered Chicago type window with a pair above. Windows on the south elevation are irregular sizes and placed asymmetrically. At the east elevation, a one story two-car garage has been attached. Its flat roof continues out to form an at-grade covered porch at the southeast corner. The tall narrow double-hung 1/1 windows have been replaced and their frames have been clad. Small rectangular basement windows pierce the foundation at irregular locations. The massing...
