Property Information

Address: 223 E Lincoln PIN: 05-26-434-021
 Building Names: Colonel Joel Walker Residence
 Important Dates: 1841 (construction date)
 Historic Function: Residence
 Current Function: Residence
 Color Code Criteria: Red
 Outbuildings
 Number: 1 Any Significant:
 Architectural Style: Greek Revival
 Property Type: Residential
 Approximate Age: 1840-1849
 Condition: Good
 Potential for Integrity?

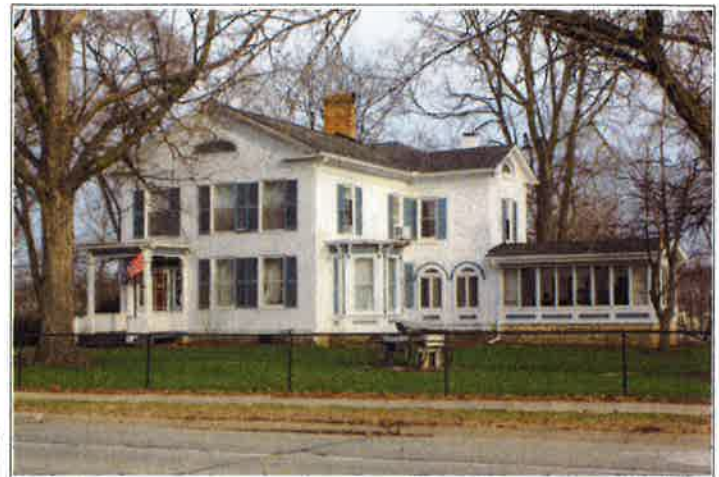
Photo: 223_E_Lincoln_Ave_SURVEY_Photo.tif

The Greek Revival, single family brick home is two stories with a cross-gabled roof and an L-shaped plan. The foundation is parged and the brick, though heavily painted, is cream colored. The walls, considered the first of brick construction in the city, are rudimentary but laid evenly in a makeshift common bond and stabilized by an iron tie rod with an "S" plate. The front gable end, facing north, spans three windows bays wide with the main entrance at one side. In combination with a central chimney stack, this suggests a side hall plan one-and-one-half rooms wide. The entry porch has a flat roof, bracketed cornice with dentils, chamfered corner posts and pilasters and a simple railing. This reconstructed porch mimics detailing found on a west side bay, but historic photographs reveal there was once a full-width porch. The main entry door is paneled with leaded glass sidelights, a full width transom, rope-like trim and floral corner blocks. The cornice, discontinuous across the gable ends, is wide with several bands of trim. Elliptical fan lites/vents are situation at the attic gable ends. Set back two window bays, the cross gabled section, running east and west, is similarly detailed. At the east, facing Main Street, is a side entrance with a porch similar to the front. At the west elevation, a three-sided window...

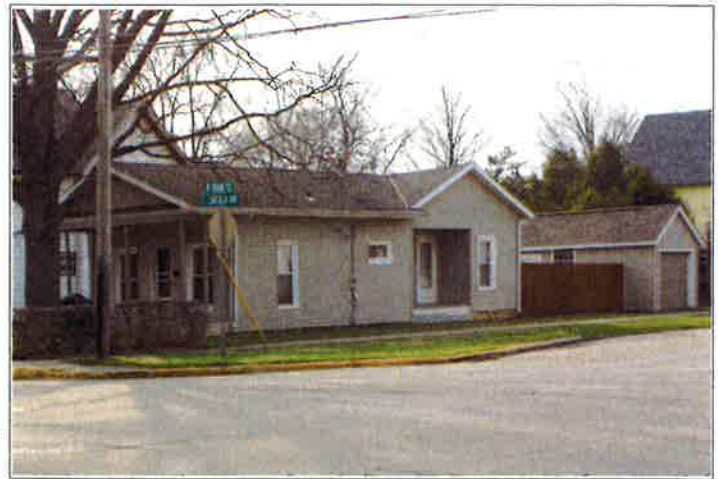
Photo: 226_E_Lincoln_Ave_SURVEY_Photo.tif

Address: 226 E Lincoln PIN: 05-26-431-010
 Building Names:
 Important Dates:
 Historic Function: Residence
 Current Function: Residence
 Color Code Criteria: Yellow
 Outbuildings
 Number: 1 Any Significant:
 Architectural Style: Settlement
 Property Type: Residential
 Approximate Age: 1850-1859
 Condition: Good/Excellent
 Potential for Integrity?

The single family shotgun dwelling is one story has a front and cross-gabled roof with a rectangular plan. The first floor is raised on rough-cut limestone foundation and the walls appear to be brick clad in siding. The primary façade, facing south, is symmetrical with a prominent front gable and a recessed front porch. The front gable is closed, and the porch has been altered with a slab stoop and plain square post supports. At the porch, the single-leaf main entrance door is flanked by two 1/1 double hung windows, all of which are replacements. To the north, a cross gable roof defines the rear elevation. Facing east, a recessed side porch contains an original door set with arch-top lites and paneling. Opposite on the west elevation, a small shed roof frame addition with various window types has been built. The tall, narrow 1/1 windows openings have rectangular sash and many have been replaced. Towards the northeast corner of the property, there is a gabled one car garage clad in siding with multi-pane windows. Though little to no detailing remains, historic photographs confirm that this modest shotgun dwelling likely had a Folk Victorian or Italianate style. However, much of the home's integrity has been lost.

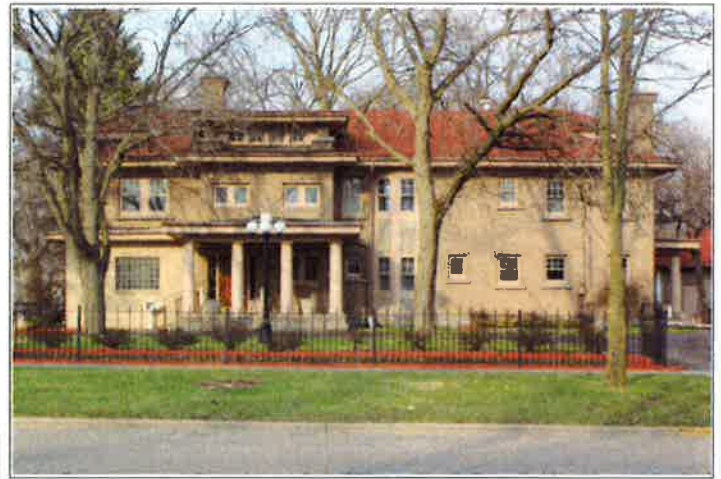
Photo: 303_E_Lincoln_Ave_SURVEY_Photo.tif

Address: 303 E Lincoln PIN: 05-25-301-007
 Building Names: J C Foote Residence
 Important Dates: 1913 (date of construction)
 Historic Function: Residence
 Current Function: Residence
 Color Code Criteria: Red
 Outbuildings
 Number: 1 Any Significant:
 Architectural Style: Prairie Style
 Property Type: Residential
 Approximate Age: 1910-1919
 Condition: Good/Excellent
 Potential for Integrity?

The Prairie Style, single family home is two-and-one-half stories tall with a low, hipped roof and rectangular massing. The foundation is coursed, rock-faced granite and the walls are tan brick with two story, shallow, half-timber and stucco window bays. The brick is corbelled at the deep eaves to simulate dentil moulding. The front façade, facing north, is symmetrical with centered, two story window bays, dormer and corbelled brick chimney. Low pitched hipped roof porches extend from the east and west elevations, completing a balanced assembly. The east façade, asymmetrical in layout, contains the primary entrance. Located below a large roof dormer, the entrance is accessed through an open porch. Squat, tapered, turned Doric columns sit atop a granite knee wall. Originally a porte-cochère, a concrete slab and steps have been poured raise the floor level. The entry door is paneled with simple wood inlay and leaded, beveled glass sidelights. Adjacent to the front entry and porch, an enclosed entry of brick and glass block was added for separate access to the basement. The east elevation porch, fitted with a granite foundation, is enclosed with large 9/1 double hung windows set between the squat Doric columns. The rear elevation, facing south, also has a columned entry porch, hipped...

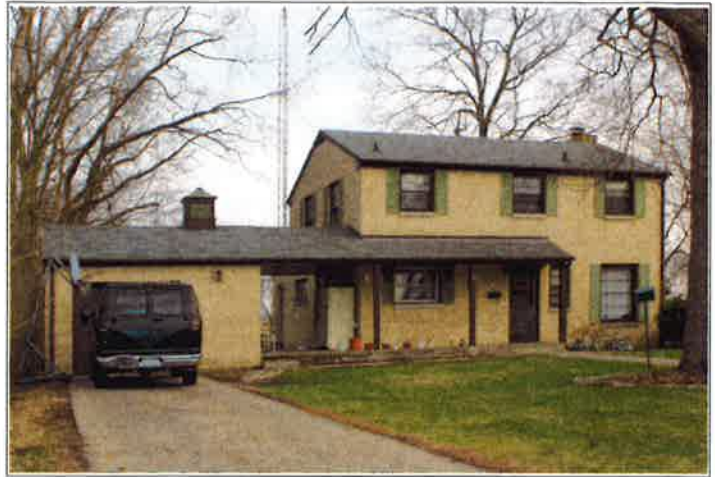
Photo: 319_E_Lincoln_Ave_SURVEY_Photo.tif

Address: 319 E Lincoln PIN: 05-25-301-008
 Building Names:
 Important Dates: 1954 Date of Construction
 Historic Function: Residence
 Current Function: Residence
 Color Code Criteria: Orange
 Outbuildings
 Number: 0 Any Significant:
 Architectural Style: Mid-Century
 Property Type: Residential
 Approximate Age: 1930-1939
 Condition: Good/Excellent
 Potential for Integrity?

This Minimal Traditional single family home is two stories tall with rectangular plan, side gabled roof and a one-car garage attached with a breezeway. Set on a concrete foundation, the walls are a yellow brick veneer and a broad brick chimney is located at the west gable end wall. The primary massing is three window bays wide by two bays deep with a small one story entrance at the southeast corner. The main entrance is on center off a concrete porch stoop that spans 2/3 of the front façade. The porch shed roof porch is supported by plain square posts and extends past the main massing to form a gable roof breezeway which merges into the garage roof. The original single leaf slab entrance door has one lite while the storm door features has multiple lites and cross-buck paneling below. Adjacent to the door is a small 2/2 window. Large 2/2 double hung windows wrap around the living area at the northwest corner, while smaller 2/2 windows appear at the second floor sleeping areas. The original 2/2 double-hung windows remain and have stone sills and faux shutters. Across the breezeway, the small one car garage is also built of brick and has a paneled garage door with lites. At the breezeway/garage roof there is a small cupola roof...

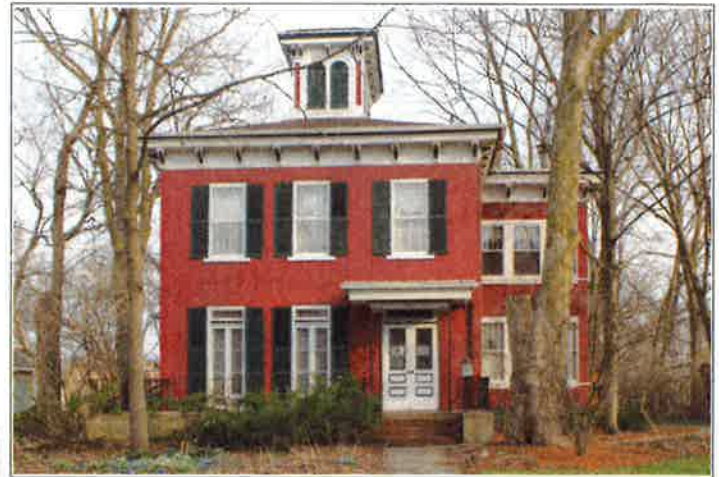
Photo: 401_E_Lincoln_Ave_SURVEY_Photo.tif

Address: 401 E Lincoln PIN: 05-25-301-002
 Building Names: Old Dunton Home
 Important Dates:
 Historic Function: Residence
 Current Function: Residence
 Color Code Criteria: Red
 Outbuildings
 Number: 1 Any Significant:
 Architectural Style: Italianate
 Property Type: Residential
 Approximate Age: 1860-1869
 Condition: Good/Excellent
 Potential for Integrity?

The Italianate, single family brick home is two stories with a low hipped roof, cupola, and tall, rectangular massing. The first floor is raised on a parged masonry foundation and the brick, laid in a running bond, has been painted. The cornice board is wide with single and paired brackets. A rear two story, gabled roof, brick kitchen wing extends to the south, and a two story enclosed side porch addition extends off the west elevation. The front façade, facing north, is three window bays wide with a one story entry porch to one side. This layout, including the kitchen wing, suggests an extended side hall floor plan. The main entrance is located under an unoriginal, flat roofed porch with simple trim, simple metal scroll-work supports and railings, and a concrete stoop. The stoop continues across the entire façade, forming a shallow veranda. The pair of entrance doors are paneled with lites and an overhead transom. Two tall first floor window openings extend to the veranda with French door and transoms. Historic photographs show a full width porch that wrapped around the west elevation. The original porch was bracketed with square chamfered posts, a short mansard, flat roof and a deck supported on square brick footings. The main roof is topped with a rectangular, hipped roof, cupola two...

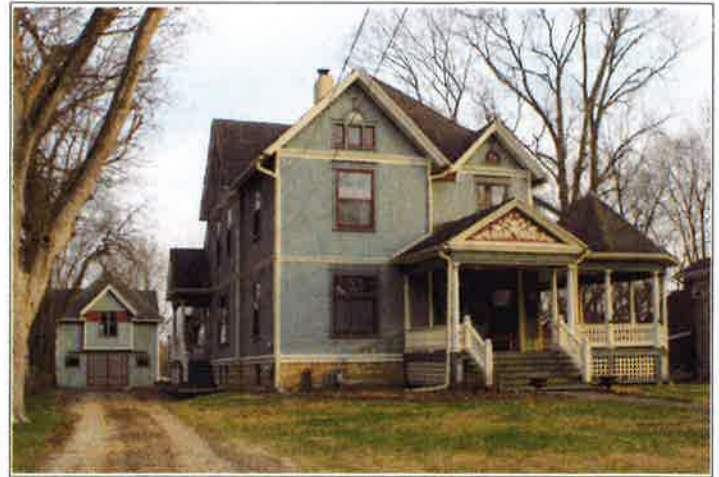
Photo: 405_E_Lincoln_Ave_SURVEY_Photo.tif

Address: 405 E Lincoln PIN: 05-25-301-003
 Building Names: Benjamin S. Herbert Residence
 Important Dates: 1895 (construction date)
 Historic Function: Residence
 Current Function: Residence
 Color Code Criteria: Red
 Outbuildings
 Number: 3 Any Significant:
 Architectural Style: Queen Anne
 Property Type: Residential
 Approximate Age: 1890-1899
 Condition: Excellent
 Potential for Integrity?

The Queen Anne, single family frame house is two-and-one-half stories with a steeply pitched hipped roof with lower cross gables, giving each façade an asymmetrical appearance. The first floor is raised on a coursed, rock-faced limestone foundation, the exterior is clad in wood clapboard and the chimney stack is centrally located. At the primary elevation, facing north, a dominant gable-front section extends slightly forward from the hipped-roof section and a smaller gable at the northwest corner. The first and second floor windows are centered below the third level's closed gable ends, which are decorated with shaped shingles and Palladian inspired windows. Wrapping around the front and west, a one story, gabled and turreted roof porch is supported by slender turned columns. The porch is decorated with lacy, flat, jig-saw cut porch balusters, simple lattice and lacy appliqué in the gabled pediments. The single-leaf 1-lite paneled entrance door is set with a decorative, spindled screen door. At the west façade, the gabled bay is canted, with decorative brackets to support the overhanging corners. The single, tall, double-hung 1/1 windows have rectangular sash with simple wood framing. At the primary elevations, there are several picture windows with leaded glass transoms. Small rectangular 1-lite...

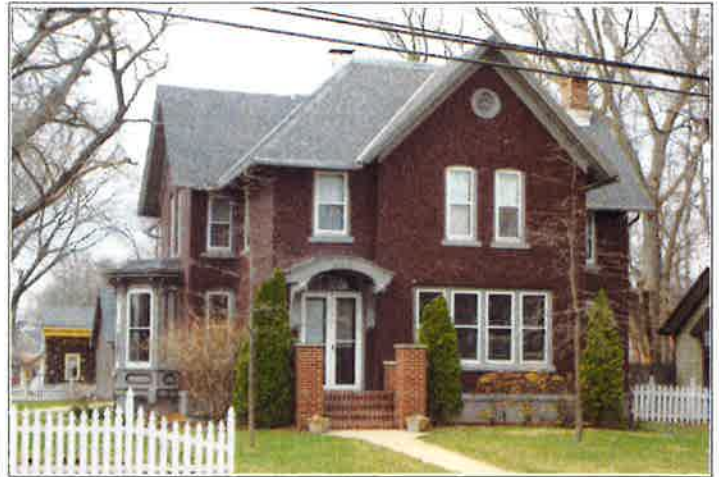
Photo: 406_E_Lincoln_Ave_SURVEY_Photo.tif

Address: 406 E Lincoln PIN: 05-25-159-007
 Building Names:
 Important Dates: 1881 (construction date)
 Historic Function: Residence
 Current Function: Residence
 Color Code Criteria: Red
 Outbuildings
 Number: 1 Any Significant:
 Architectural Style: Queen Anne
 Property Type: Residential
 Approximate Age: 1880-1889
 Condition: Excellent
 Potential for Integrity?

The Queen Anne, single family brick house is two-and-one-half stories with a steeply pitched hipped roof and cross-gabled massing with central and gable-end chimney stacks. The first floor is raised on a parged masonry foundation and water table, and the brick is painted. At the primary elevation, facing south, a gable-front section with centered window openings extends one window bay forward from the cross gable section. The cross gable ends extend one window bay beyond at the west and two bays at the east. The main entrance is situated at the south west corner under the hipped roof. Over the door, a bracketed, arched porch roof echoes the segmental curve of the entry transom, which is situated over a pair of paneled entrance doors with tall lites. A modern brick stoop and knee walls finish the front entrance. The west and east elevation gable end windows are also centered. At the first floor on the west, there is a three-sided frame window bay with a masonry foundation, paneled detail, a bracketed cornice and flat, short and sloping mansard roof. Single, tall and narrow double-hung, 1/1 windows have rectangular sash with segmental arch brick headers and stone lug sills. Small rectangular basement windows, now glass block, pierce the foundation and small, 1-lite oculus attic...

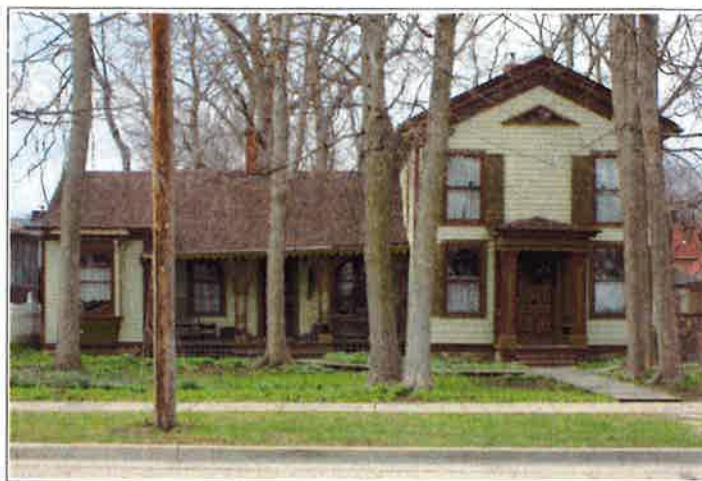
Photo: 410_E_Lincoln_Ave_SURVEY_Photo.tif

Address: 410 E Lincoln PIN: 05-25-159-008
 Building Names: Wildflower House/Lampert Home
 Important Dates: 1837 (construction date)
 Historic Function: Residence
 Current Function: Residence
 Color Code Criteria: Red
 Outbuildings
 Number: 4 Any Significant:
 Architectural Style: Greek Revival
 Property Type: Residential
 Approximate Age: 1830-1839
 Condition: Excellent
 Potential for Integrity?

The Greek Revival, single family frame house has upright-and-wing massing with a two-and-one-half story front facing gable and a one story side-gabled wing. The house is set on a rubble limestone foundation and is clad in wood clapboarding. Facing south, the upright section is two bays deep with a symmetrical façade of two windows flanking a central entrance. A central chimney is located at the rear gable end wall. The cornice, discontinuous across the gable ends, is wide with several bands of trim. The paneled front door is located under a small, hipped roof porch with a wide cornice band, large square, paneled columns, and simple railings and window seats.

Such a small porch is typical for Midwest examples of this style. However, the current porch dates to ca. 1870s. Square, chamfered posts and pilasters support a bracketed, low, hipped roof embellished with spear-shaped dentils. A simple railing terminates in ball-topped newel posts. The entrance door is paneled, with wide, simple wood trim at the door surround. On the rear elevation there is a full-width one story wing with a concrete foundation and a partial two story addition. ...

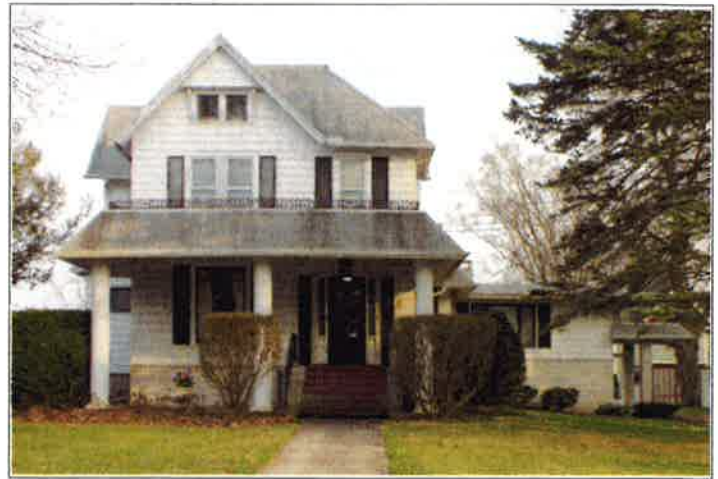
Photo: 415_E_Lincoln_Ave_SURVEY_Photo.tif

Address: 415 E Lincoln PIN: 05-25-301-004
 Building Names:
 Important Dates:
 Historic Function: Residence
 Current Function: Residence
 Color Code Criteria: None
 Outbuildings
 Number: 1 Any Significant:
 Architectural Style: Queen Anne
 Property Type: Residential
 Approximate Age: 1890-1899
 Condition: Good
 Potential for Integrity?

The Queen Anne, single family frame house is two-and-one-half stories with a steeply pitched hipped and cross-gabled massing. The first floor is raised on a foundation of coursed limestone, the exterior is clad in siding and partial stone veneer, and the brick chimney is centrally located on the roof. The primary elevation, facing north, is asymmetrical with an open front gable. The cross gables face east and west with a gabled rear wing to the south. At the north elevation, a one story porch has a mansard and flat roof support by large fluted columns set at grade. A small concrete stoop and steps are located under the porch. Here the main entrance has been remodeled to a colonial revival assembly with sidelites and a broken scroll pediment. The mansard porch roof wraps around the west elevation and merges with a one story hipped roof addition and continues around the south elevation. The addition has a side entrance at grade with a short mansard and flat porch roof supported by square stone veneered columns. At the main body of the house, many of the original windows remain. Under the west gable a centered rectangular window bay is partially visible. Single and paired windows are centered under the open...

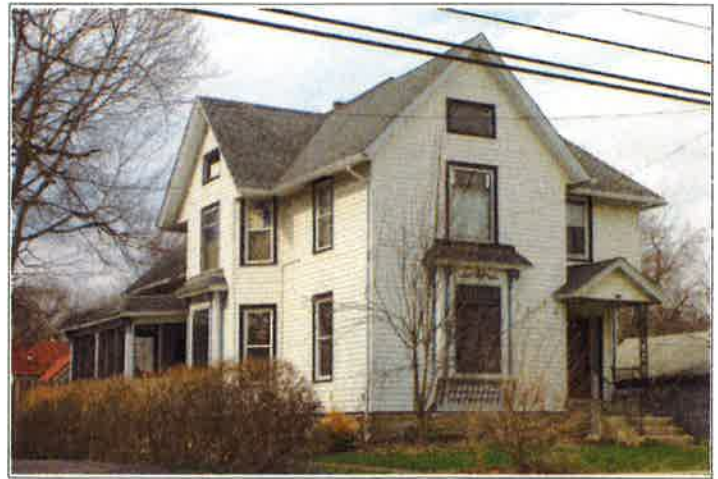
Photo: 416_E_Lincoln_Ave_SURVEY_Photo.tif

Address: 416 E Lincoln PIN: 05-25-159-009
 Building Names: E. Hopkins Residence
 Important Dates:
 Historic Function: Residence
 Current Function: Residence
 Color Code Criteria: Yellow
 Outbuildings
 Number: 0 Any Significant:
 Architectural Style: Queen Anne
 Property Type: Residential
 Approximate Age: 1890-1899
 Condition: Good/Excellent
 Potential for Integrity?

The Queen Anne, single family frame house is two-and-one-half stories with a steeply pitched roof and cross-gabled massing. The first floor is raised on a foundation of dressed, rusticated limestone and the exterior is clad in siding. At the primary elevation, facing south, a gable-front section with centered window openings extends forward from the hipped roof section, where the main entry is placed at the southeast corner. The altered main entrance is situated on a concrete rock-faced block base under a small gabled porch roof supported by cast metal lattice posts. The single-leaf entrance door has been replaced, and directly adjacent is a canted first floor window bay. The south elevation gable end windows are centered with a cantilevered window bay at the first floor. The bays are bracketed with a shingled spandrel, scrollwork appliqué, a bracketed cornice and a short mansard roof. The front windows have decorative glass transoms over picture windows with a one-lite attic sash high in the gable end. The east and west gables have symmetrical window placement and the west gable's first floor is canted with a repeat of the south elevation's bay and large window layout. A small one-story enclosed side porch with...

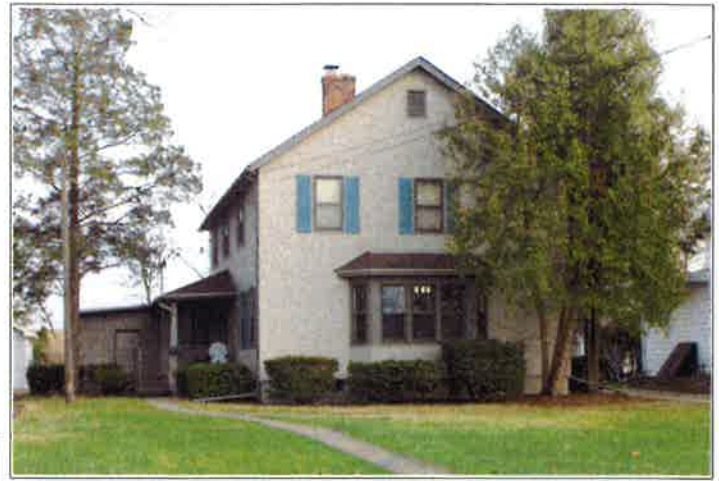
Photo: 421_E_Lincoln_Ave_SURVEY_Photo.tif

Address: 421 E Lincoln PIN: 05-25-301-005
 Building Names:
 Important Dates:
 Historic Function: Residence
 Current Function: Residence
 Color Code Criteria: None
 Outbuildings
 Number: 0 Any Significant:
 Architectural Style: None
 Property Type: Residential
 Approximate Age: 1930-1939
 Condition: Heavily Altered
 Potential for Integrity?

The single family frame house is two stories with a steeply pitched roof and front gabled massing. The first floor is raised on a concrete foundation, the exterior is clad in siding, and a broad brick chimney is located towards the south elevation. At the primary elevation, facing north, the first floor has a wide, centered window bay with double-hung windows and a hipped roof. Above, two double-hung windows with faux shutters are placed off center. The main entry is placed to the side on the east elevation where a wood deck and hipped roof is supported by a turned colonnette. The single-leaf entry door has been replaced. Opposite on the west elevation, a smaller wood deck is located at a side entrance. Typical windows have been replaced with single 1/1 double-hungs with rectangular sash and faux shutters. Small rectangular 3-lite basement windows pierce the foundation. The home's 1930s construction date, orientation and arrangement of features appear to place it in the Colonial Revival style. However, extensive remodeling has removed a majority of the home's original fabric and decorative elements, compromising its integrity.

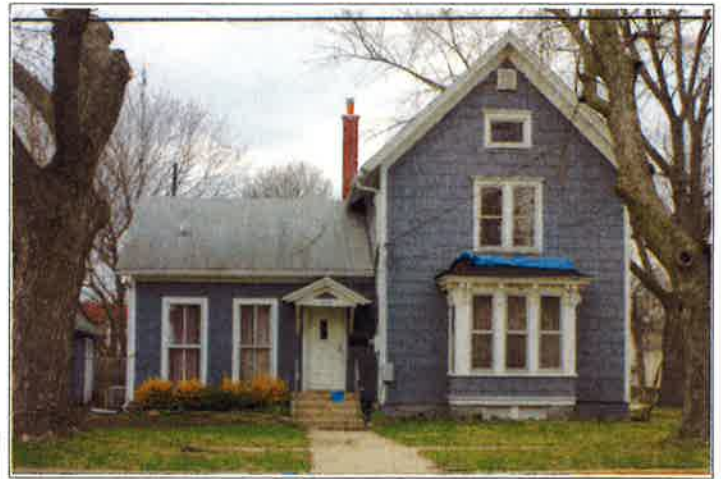
Photo: 426_E_Lincoln_Ave_SURVEY_Photo.tif

Address: 426 E Lincoln PIN: 05-25-159-010
 Building Names:
 Important Dates:
 Historic Function: Residence
 Current Function: Residence
 Color Code Criteria: Orange
 Outbuildings
 Number: 1 Any Significant:
 Architectural Style: Queen Anne
 Property Type: Residential
 Approximate Age: 1870-1879
 Condition: Good
 Potential for Integrity?

The Victorian, single family frame house is two-and-one-half stories with a steeply pitched front gabled roof and a one-and-one-half story side gabled wing. The first floor is raised on a parged masonry foundation and the exterior is clad in asbestos siding. At the primary elevation, facing south, the gable-front section has centered window openings. A rectangular bay at the first floor has a short mansard roof accented with paired and single brackets, and a pair of windows is located above at the second floor. The main entry is placed at a concrete stoop in the southeast corner of the wing with two original floor-to-ceiling 2/2 double-hung windows adjacent. The single-leaf door is replaced, with a gabled canopy supported with simple braces. The wing's west elevation gable end window are original 2/2 double-hungs, evenly spaced with pedimented wood frames. The east elevation window placement is irregular with original 2/2 and 1/1 windows. Small rectangular basement windows pierce the foundation and are located high in the attic gable. Many of the original windows remain, though their framing details vary and replacement storm windows have been installed. At the rear elevation, a small...

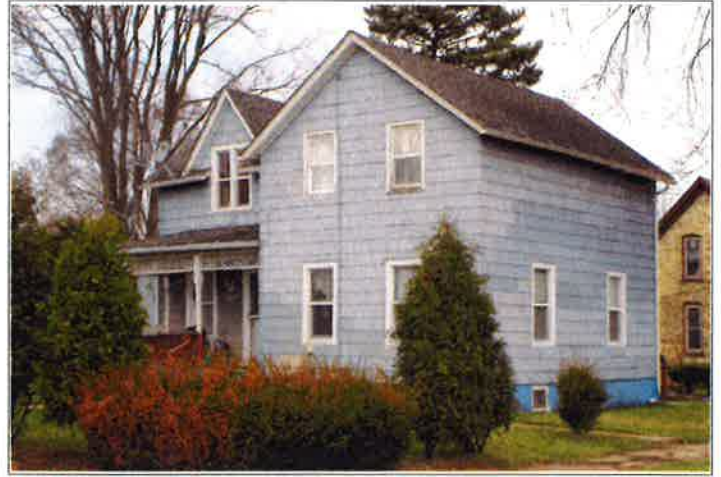
Photo: 222_E_Hurlbut_Ave_SURVEY_Photo.tif

Address: 222 E Hurlbut PIN: 05-26-287-010
 Building Names:
 Important Dates:
 Historic Function: Residence
 Current Function: Residence
 Color Code Criteria: Yellow
 Outbuildings
 Number: 0 Any Significant:
 Architectural Style: Greek Revival
 Property Type: Residential
 Approximate Age: 1850-1859
 Condition: Poor
 Potential for Integrity?

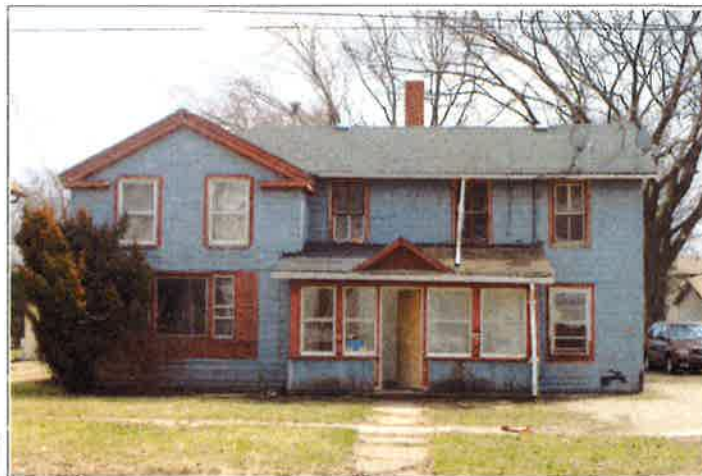
Photo: 309_E_Madison_St_SURVEY_Photo.tif

Address: 309 E Madison PIN: 05-26-288-002
 Building Names:
 Important Dates:
 Historic Function: Residence
 Current Function: Apartments
 Color Code Criteria: Yellow
 Outbuildings
 Number: 0 Any Significant:
 Architectural Style: Greek Revival
 Property Type: Residential
 Approximate Age: 1860-1869
 Condition: Poor
 Potential for Integrity?
