**Courthouse Square Area**

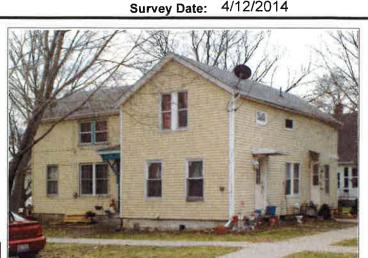
Photo: 421\_E\_Madison\_St\_SURVEY\_Photo.tif Description

The multi-unit frame house is one-and-one-half stories with upright and wing massing, "T" shaped plan and a gabled addition. The street elevation is the side of the house, with the formal front elevation facing east. The front gabled plan spans two bays wide by four bays deep. The first floor is set on a parged masonry foundation and the walls are clad in siding. An internal brick chimney is located on center at the roof junction. The upright façade, facing east, is symmetrical with two windows at the first floor and a pair of windows in the gable. The arrangement is repeated at the west gable end wall. Along the north elevation are two irregularly spaced single-leaf entrance doors, two pairs of windows and two small eave windows. The wing is three bays wide by two bays deep. At the northeast inside corner, a single-leaf door has been replaced and is located at a low concrete stoop. Over the door there is a short mansard porch canopy supported by an elaborately turned bracket. Many of the windows have been replaced, with some 6/1 double -hung wood windows remaining at the northwest corner. On the rear elevation there is a one story gabled addition that is possibly an original kitchen wing. Set at the south...
