**Property Information**

Belvidere Old Town District

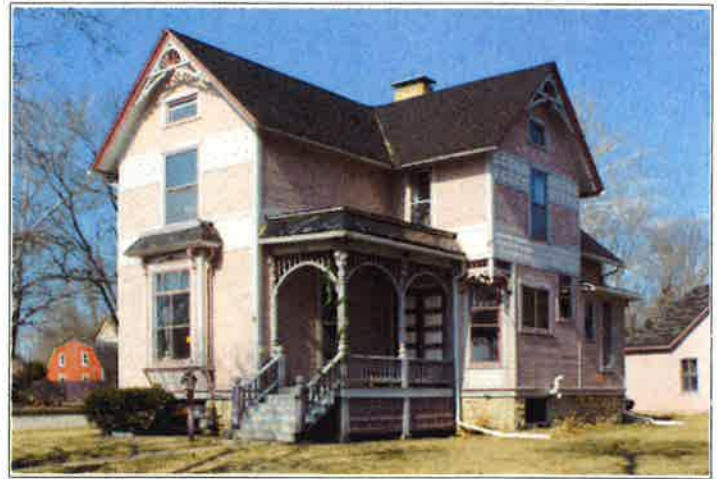
Photo: 619\_N\_State\_St\_SURVEY\_Photo.tif

Address: 619 N State PIN: 05-26-262-001  
 Building Names: Clyde Andrus Residence  
 Important Dates:  
 Historic Function: Residence  
 Current Function: Residence  
 Color Code Criteria: Red  
 Outbuildings  
 Number: 1 Any Significant:   
 Architectural Style: Queen Anne  
 Property Type: Residential  
 Approximate Age: 1880-1889  
 Condition: Good  
 Potential for Integrity?

The Queen Anne, single family frame house is two-and-one-half stories with a steeply pitched roof and cross-gabled massing. The first floor is raised on a foundation of dressed, rusticated limestone and the exterior is clad in wood clapboard. A band of alternating fish scale and spear shingles encircles the second floor level, while a band of lattice spanning the gable ends and level with the top of the second floor windows is infilled with pyramidal relief. At the primary elevation, facing west, a gable-front section with centered window openings extends one window bay forward. The north/south cross gables extend one window bay beyond. The main entrance is situated at the south west corner under a wood side porch. Its short, mansard, flat roof is supported by turned, bracketed columns and a spindled railing, arched spindle frieze, and cut-out latticework enhance the porch. The pair of entrance doors are paneled. The south elevation gable end windows are also centered, but the first floor is canted next to the main entry and accentuated with corner bracketing and decoration. At the first floor on the west and north gables, there are cantilevered window bays with decorative glass transoms over picture windows. The...

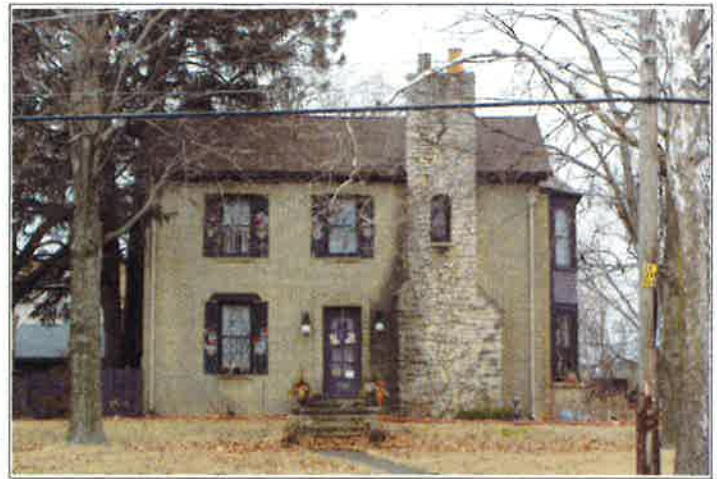
Photo: 705\_N\_State\_St\_SURVEY\_Photo.tif

Address: 705 N State PIN: 05-26-257-003  
 Building Names:  
 Important Dates:  
 Historic Function: Residence  
 Current Function: Residence/Store  
 Color Code Criteria: Orange  
 Outbuildings  
 Number: 1 Any Significant:   
 Architectural Style: Tudor Revival  
 Property Type: Residential  
 Approximate Age: 1900-1909  
 Condition: Good/Excellent  
 Potential for Integrity?

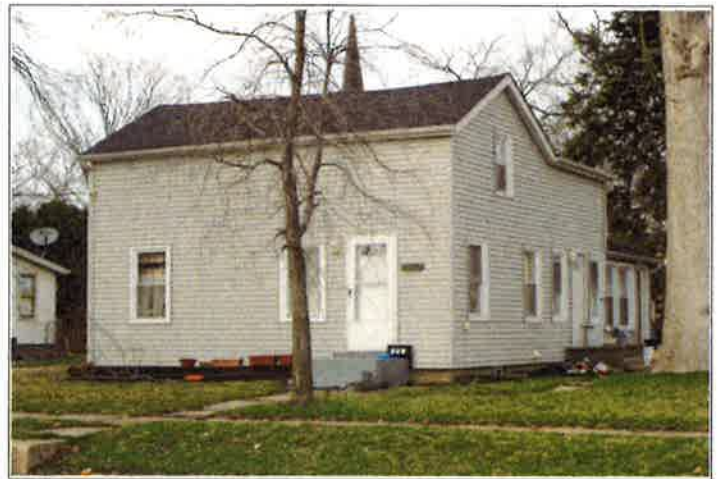
Photo: 215\_Van\_Buren\_St\_SURVEY\_Photo.tif

Address: 215 Van Buren PIN: 05-26-431-003  
 Building Names:  
 Important Dates:  
 Historic Function: Residence  
 Current Function: Residence  
 Color Code Criteria: Yellow  
 Outbuildings  
 Number: 1 Any Significant:   
 Architectural Style: None  
 Property Type: Residential  
 Approximate Age: 1870-1879  
 Condition: Fair  
 Potential for Integrity?

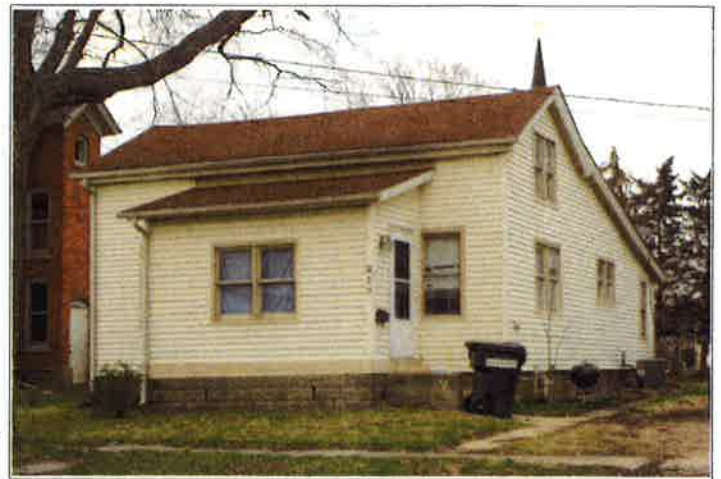
Photo: 217\_Van\_Buren\_St\_SURVEY\_Photo.tif

Address: 217 Van Buren PIN: 05-26-431-002  
 Building Names:  
 Important Dates:  
 Historic Function: Residence  
 Current Function: Residence  
 Color Code Criteria: Yellow  
 Outbuildings  
 Number: 0 Any Significant:   
 Architectural Style: None  
 Property Type: Residential  
 Approximate Age: 1870-1879  
 Condition: Fair  
 Potential for Integrity?

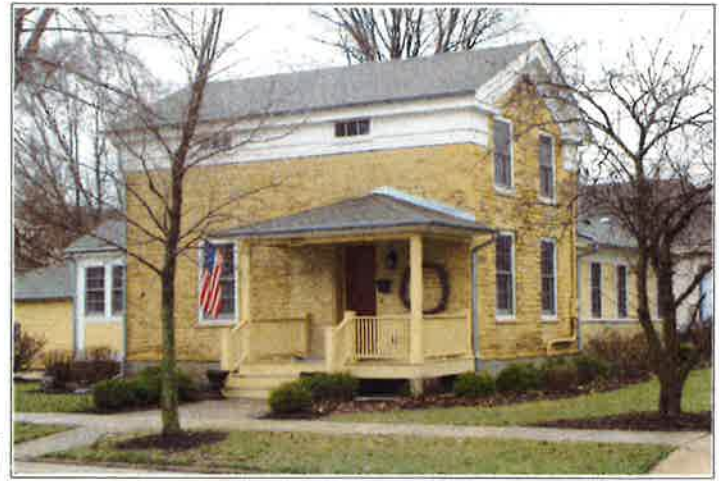
Photo: 303\_Van\_Buren\_St\_SURVEY\_Photo.tif

Address: 303 Van Buren PIN: 05-26-287-007  
 Building Names: William Perkins Residence  
 Important Dates: 1852  
 Historic Function: Residence  
 Current Function: Residence  
 Color Code Criteria: Orange  
 Outbuildings  
 Number: 1 Any Significant:   
 Architectural Style: Settlement  
 Property Type: Residential  
 Approximate Age: 1850-1859  
 Condition: Excellent  
 Potential for Integrity?

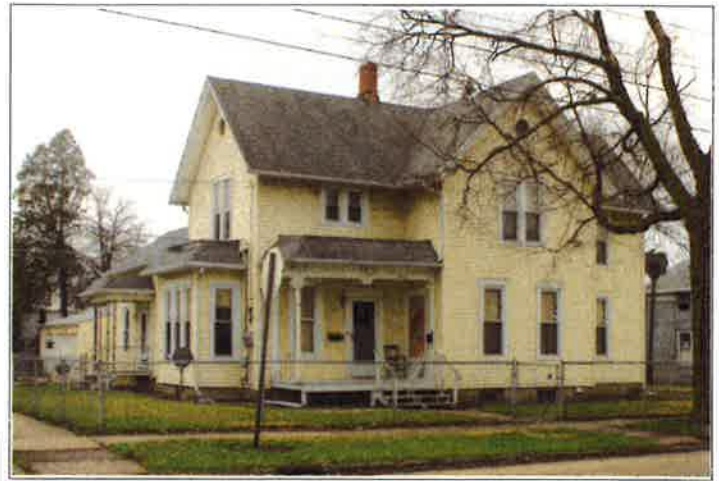
Photo: 304\_Van\_Buren\_St\_SURVEY\_Photo.tif

Address: 304 Van Buren PIN: 05-26-427-008  
 Building Names:  
 Important Dates:  
 Historic Function: Residence  
 Current Function: Residence  
 Color Code Criteria: Yellow  
 Outbuildings  
 Number: 1 Any Significant:   
 Architectural Style: Queen Anne  
 Property Type: Residential  
 Approximate Age: 1890-1899  
 Condition: Good  
 Potential for Integrity?

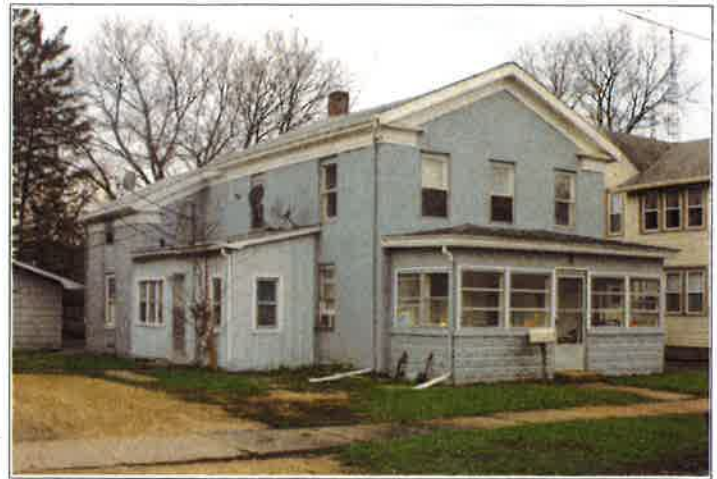
Photo: 312\_Van\_Buren\_St\_SURVEY\_Photo.tif

Address: 312 Van Buren PIN: 05-26-427-007  
 Building Names:  
 Important Dates:  
 Historic Function: Residence  
 Current Function: Apartments  
 Color Code Criteria: Orange  
 Outbuildings  
 Number: 1 Any Significant:   
 Architectural Style: Greek Revival  
 Property Type: Residential  
 Approximate Age: 1850-1859  
 Condition: Fair  
 Potential for Integrity?

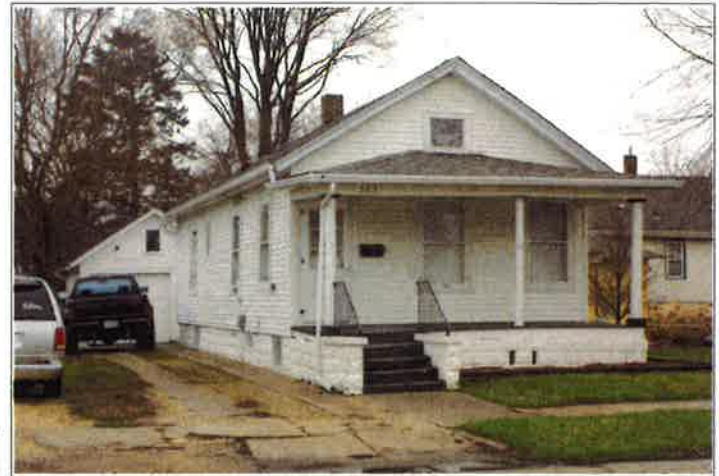
Photo: 313\_Van\_Buren\_St\_SURVEY\_Photo.tif

Address: 313 Van Buren PIN: 05-26-287-003  
 Building Names:  
 Important Dates:  
 Historic Function: Residence  
 Current Function: Residence  
 Color Code Criteria: Yellow  
 Outbuildings  
 Number: 1 Any Significant:   
 Architectural Style: Craftsman  
 Property Type: Residential  
 Approximate Age: 1920-1929  
 Condition: Good  
 Potential for Integrity?

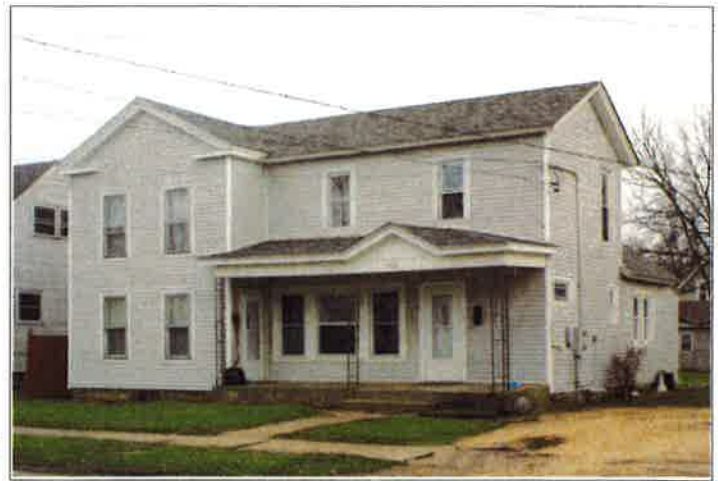
Photo: 315\_Van\_Buren\_St\_SURVEY\_Photo.tif

Address: 315 Van Buren PIN: 05-26-287-002  
 Building Names:  
 Important Dates:  
 Historic Function: Residence  
 Current Function: Apartments  
 Color Code Criteria: Yellow  
 Outbuildings  
 Number: 0 Any Significant:   
 Architectural Style: Greek Revival  
 Property Type: Residential  
 Approximate Age: 1850-1859  
 Condition: Fair  
 Potential for Integrity?

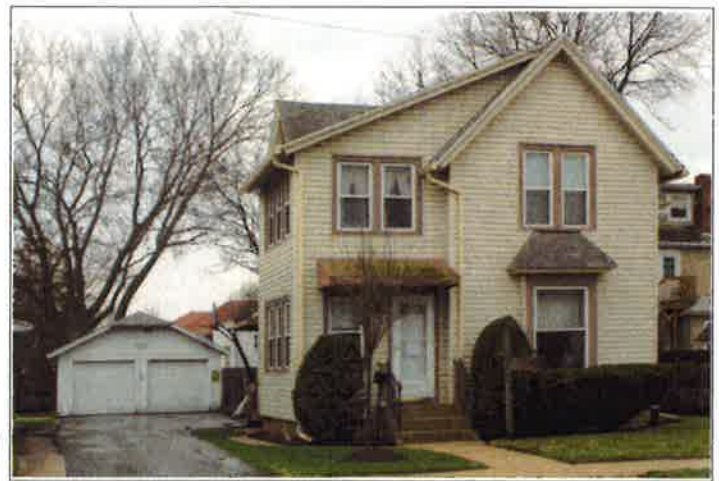
Photo: 316\_Van\_Buren\_St\_SURVEY\_Photo.tif

The Queen Anne, single family frame house is two stories with a steeply pitched roof and cross-gabled massing. The first floor is raised on a foundation of dressed, rusticated limestone and the exterior is clad in modern vinyl siding. At the primary elevation, facing east, a gable-front section with centered window openings extends one window bay forward of the north/south cross gables. These extend one window bay wide of the front gable section at each side. However, in the southeast corner, a large two story section with a concrete block foundation and shed roof was added, encompassing the original front entrance. Here, the new single leaf entrance is situated at a concrete stoop under a fabric awning. Several 1/1 double hung window groupings were installed at both sides of the corner addition. The east elevation gable end windows are centered; at the first floor there is a cantilevered window bay with a hipped roof, and a pair of windows above. Single and double, tall, double-hung, 1/1 windows with rectangular sash have been replaced and their framing has been clad. Small rectangular 1-lite basement windows pierce the foundation. A period, frame two-car garage, is clad in wood siding and sited to the west near a rear entrance. The gabled roof is clipped and the doors have been replaced. The...

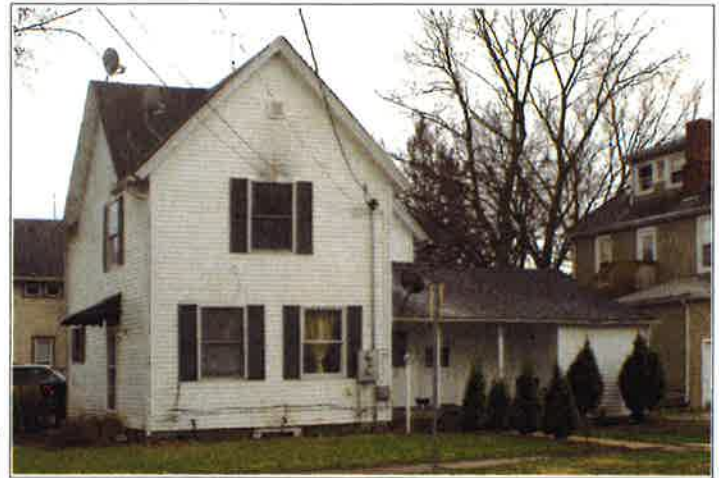
Photo: 322\_Van\_Buren\_St\_SURVEY\_Photo.tif

This single-family house is two stories tall and is composed of two primary side gabled forms and a one story rear gabled wing. At all three massings, the first floor is set on a low foundation of rubble limestone and the walls are clad in vinyl siding. Each section has a rectangular plan approximately one room deep and though they are offset, they remain joined at the central corners. A brick chimney is located at the center of the secondary side gabled section. Sited in front of the others, the primary side gabled section also has a prominent front cross gabled at the west-facing roofline. At this elevation, the single leaf main entrance is off center with a single 1/1 double hung window above and a small double hung window to the side. At the north, there are two first floor window bays and one centered window at the second floor. The windows typically have faux shutters and all other windows are small and irregularly placed. The one story gable roof wing to the west has an incorporated porch about half its length with a single-leaf entrance door situated off the concrete slab stoop. The building's small sized massing, rooflines and apparent rear kitchen wing indicate an 1860-70s construction date that perhaps places it in the Gothic...

...Revival style. However, after several updates and modernizations over time, almost all ornamentation and integrity have been lost or compromised.

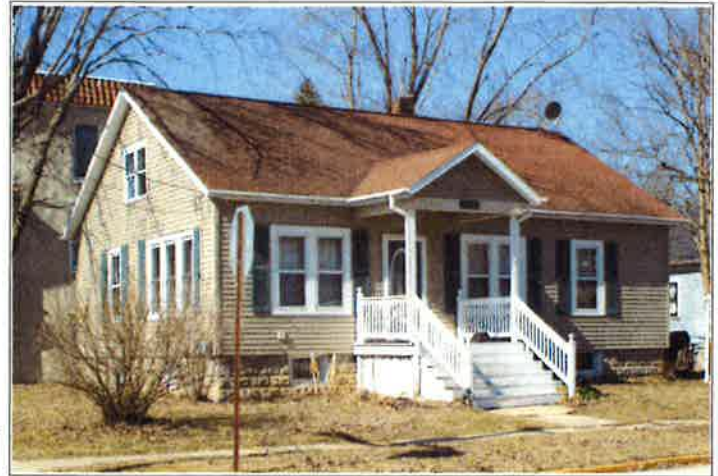
Photo: 402\_Van\_Buren\_St\_SURVEY\_Photo.tif

This single family Box Bungalow house has a rectangular plan, a side gabled roof and is one-and-one-half stories tall. Set on a raised rock-faced block foundation, the walls are frame construction and clad in vinyl siding. A brick chimney is located off-center near the ridge line. At the primary east façade, the offset main entrance is situated at a frame porch stoop which supports a front gabled roof with simple square posts. The two room deep plan places a living room at the southeast corner, highlighted with paired and triple window groupings. Other first floor window openings are single and placed irregularly with paired windows centered at the second floor gable ends. All window openings are clad and the original windows have been replaced with 1/1 double-hungs with faux 3 lite top sash. Small one lite basement windows pierce the foundation. A small gable roof shed clad in siding is located at the northwest corner of the property. Though the main massing and arrangement have been maintained, many features and materials have been replaced or altered.

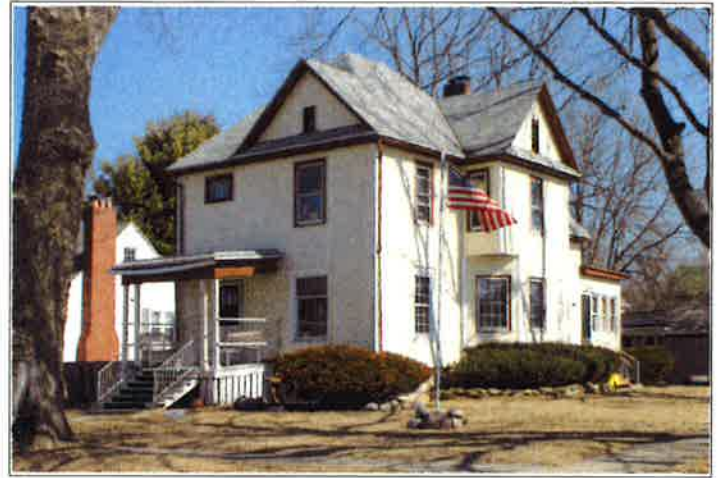
Photo: 403\_Van\_Buren\_St\_SURVEY\_Photo.tif

The Queen Anne, single family frame house is two-and-one-half stories with a steeply pitched hipped roof with cross gables, giving each façade an asymmetrical appearance. The first floor is raised on a foundation of dressed, rusticated limestone, the exterior is clad in siding, and the brick chimney is centered towards the rear wing. At the front façade, facing west, there is a prominent pented gable with centered windows at the first and second floors. A small front entrance porch is situated at the northwest corner. Simple paired square posts support a flat roof and plain wood & iron railings and lattice enclose the stoop. The single leaf entrance door has been replaced. A small Queen Anne window sash is situated above the entrance at the second floor level. The north and south cross gables are also pented at the third floor. The south gable, which extends beyond the main massing, is canted at the southwest corner. The one-and-one-half story rear wing with gabled roof extends to the east. A small one story enclosed porch at the southeast corner has a wood stoop enclosed with lattice and flat roof. The single, tall, double-hung 1/1 windows have rectangular sash with simple wood framing, and windows are paired on...

...secondary and rear elevations. A large landscape window is placed at the front façade, and stepped windows are placed along the north façade. Small rectangular 1-lite basement windows pierce the foundation, and small 1/1 double hung windows are placed in the pented gables. Most openings have aluminum storm windows installed, and some along the south elevation have been replaced with multi-lite windows. The massing and arrangement of features is typical Queen Anne homes, though most of the original detailing and materials have been removed or compromised.

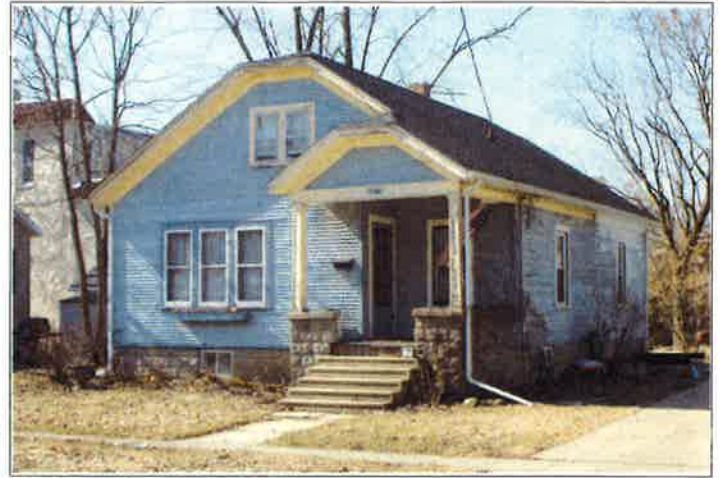
Photo: 404\_Van\_Buren\_St\_SURVEY\_Photo.tif

This single family Standard Bungalow has a front-facing clipped gable roof, rectangular plan and is one-and-one-half stories tall. Set on a raised rock-faced block foundation, the walls are frame construction and clad in wood siding. A brick chimney is located near the rear and off-center of the ridge line. At the primary east façade, the main entrance is situated to the north off a small porch. The rock-faced block foundation continues to form low porch sidewalls with shaped concrete steps. The front gabled porch roof is also clipped and is supported by simple paneled square posts. The single-leaf entrance door, located off the porch, is original with tall top lites and panels below. The room layout places a living room at the southeast corner, which is highlighted with a triple window grouping at the main façade. Other first floor window openings are single with a pair of windows at the south elevation's dining room and a short pair centered in the front gable end. The original wood windows are 3/1 double-hungs, though windows on the rear elevation have been replaced and had their frames clad. Small two-lite basement windows pierce the foundation, and most original window openings have wood storm windows installed. A...

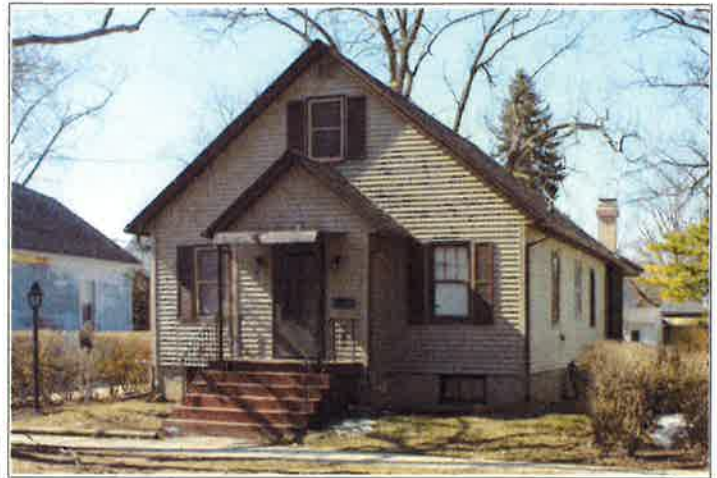
Photo: 408\_Van\_Buren\_St\_SURVEY\_Photo.jpg

This single family Box Bungalow house has a rectangular plan, a front gabled roof and is one-and-one-half stories tall. A gable roof frame addition extends from the rear elevation. Set on a raised concrete block foundation, the walls are frame construction and clad in vinyl siding. A brick chimney is located off-center near the ridge line with a second brick chimney located on the rear addition. At the primary east façade, a front gable enclosed entrance vestibule is centered on a concrete block porch stoop. A plain wood deck with simple square posts supports a ribbed metal awning. The front façade is symmetrical with single 3/1 double-hung wood windows flanking the entrance and one in the gable end. Small three-lite basement windows pierce the foundation. The rear addition is clad in vertical board-and-batten siding and appears to be from the mid-20th century. Original windows continue along the north façade, while all south façade windows have been replaced with metal casements in pairs and triple window groupings. These match the windows on the addition and appear to have been replaced at that time. At the northwest section of the "L" shaped property, a two-car front-gable garage...

...faces E. Perry St. The mid-century garage is clad in siding with a shaped garage door opening and faux strap-hinge detailing. Though most of the main massing and arrangement have been maintained, many original features and materials of this simple Bungalow have been replaced or altered.

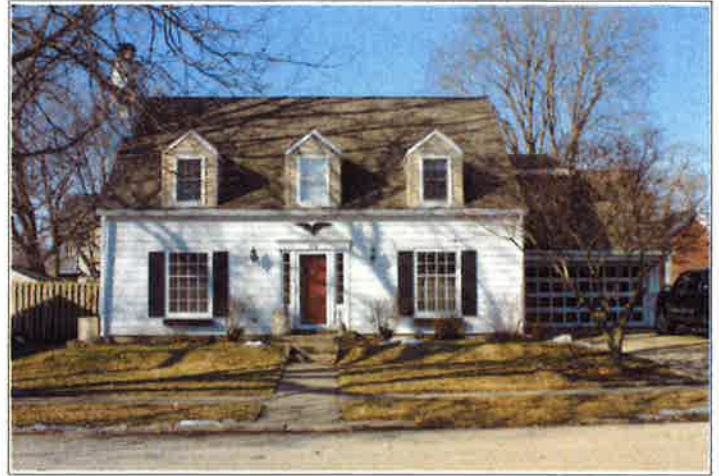
Photo: 534\_Van\_Buren\_St\_SURVEY\_Photo.tif

This single family Minimal Traditional house has a rectangular plan, a side gabled roof and is one-and-one-half stories tall. A side gable roof garage is attached at the north elevation. Set on a low concrete foundation, the walls are frame construction and clad in siding with very shallow eaves. A large brick chimney is located at the south gable end wall. The primary façade, facing east, is symmetrical with three bays. At the first floor, the main entrance is centered between two large 15-lite fixed-wood windows with faux shutters. These multi-pane windows wrap around to the north and south corners. Above there are three gable dormers clad in shingles and siding set with 6/6 double-hung windows. The original single-leaf main entrance door is paneled with multi-pane sidelights, simple reeded pilasters, and small scalloped detailing along the header. At the rear, a full-width shed roof is incorporated to enlarge the second floor rooms. The two car garage is set back with the garage door and side entrance door recessed under the front eave. Though the main footprint of the garage appears to be original, it has been altered and/or enlarged at the roofline to connect to the second floor. The main massing and arrangement original..

...features make this a Cape Cod style Minimal Traditional house. Though the majority of the massing and arrangement of elements has been maintained, several materials and elements have been replaced or altered.

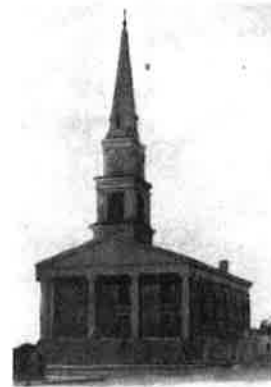
FirstPresbyterianChurch 1858.jpg

*Present Church Building  
Dedicated 1858*

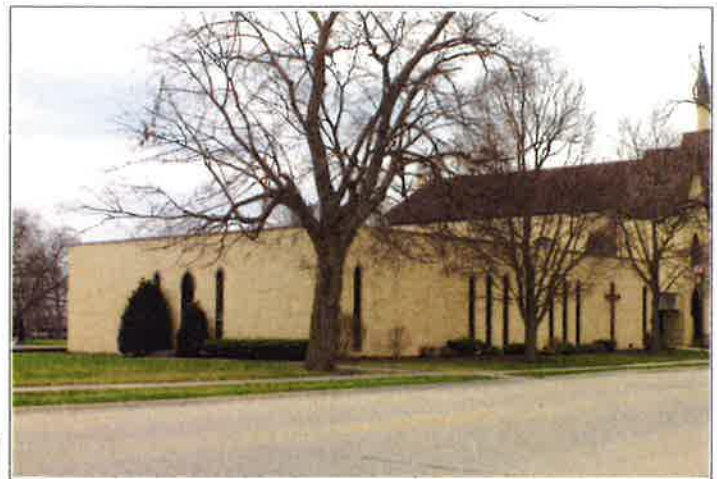
Photo: 221\_N\_Main\_St\_SURVEY\_Photo\_Fellowship\_Hall.tif  
**Description**

Address: 221 N Main PIN:  
 Building Names: First Presbyterian Church Fellowship Hall  
 Important Dates: 1975 Date of Construction  
 Historic Function:  
 Current Function:  
 Color Code Criteria: Blue  
 Outbuildings  
 Number: Any Significant:   
 Architectural Style: Modern  
 Property Type:  
 Approximate Age: 1970-1979  
 Condition: Good/Excellent  
 Potential for Integrity?

Located to the north of the Victorian Gothic First Presbyterian Church, this mid-century modern brick addition is one story tall with a flat roof and rectangular massing. This Fellowship Hall is connected to the main church by a low hyphen and faces west. Here, a glass wall and pair of entry doors is topped by a heavy limestone slab and flat roof. The main body of the hall is constructed of brick laid in a running bond and of a cream color similar to the main church. The tall one story walls are set on a concrete slab and are capped with simple limestone coping. The west façade has symmetrical window placement with two groups of three windows flanked by a single window at each corner. A large, simple cross is also hung on the exterior near the south corner. The windows are a modern interpretation of the Gothic style and continue to play off of the main church design. They are thin lancets with pointed-arch tops, limestone lintels and limestone slip sills. Their metal frames have small vents and they are set with modern, abstract stained glass. Along the north elevation, a tall pointed-arch door opening is flanked by two typical thin lancets. Along the rear elevation, facing east, the typical lancet windows mirror the east...
