**Property Information**

Address: 222 N Main PIN: 05-26-431-014  
 Building Names:  
 Important Dates:  
 Historic Function: Residence  
 Current Function: Residence  
 Color Code Criteria: None  
 Outbuildings  
 Number: 0 Any Significant:   
 Architectural Style: Colonial Revival  
 Property Type: Residential  
 Approximate Age: 1900-1909  
 Condition: Heavily Altered  
 Potential for Integrity?

Individual Eligibility   
 District Eligibility:   
 District Name:  
 Belvidere Old Town District

Individual Eligibility:   
 District Eligibility:   
 District Name:  
 Belvidere Courthouse Square  
 Local Historic District

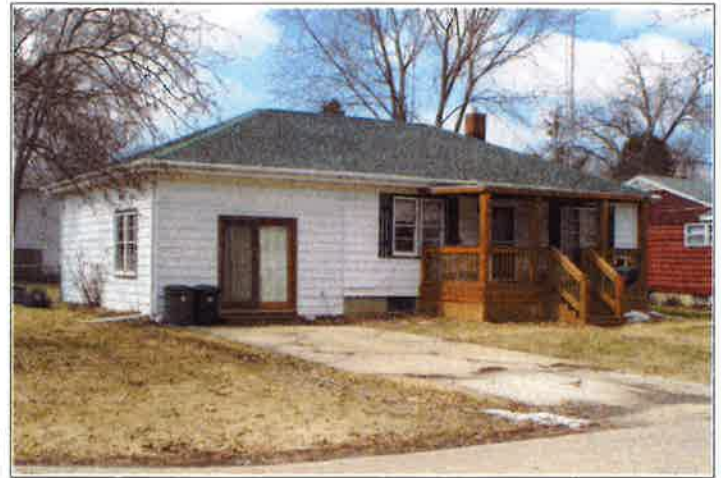
Photo: 704\_Hancock\_St\_SURVEY\_Photo.tif

Address: 704 Hancock PIN: 05-26-234-009  
 Building Names:  
 Important Dates:  
 Historic Function: Residence  
 Current Function: Residence  
 Color Code Criteria: None  
 Outbuildings  
 Number: 1 Any Significant:   
 Architectural Style: Mid-Century  
 Property Type: Residential  
 Approximate Age: 1940-1949  
 Condition: Fair  
 Potential for Integrity?

The box ranch, single family frame home is one story with rectangular plan, hipped roof and boxed eaves. The first floor is raised on a concrete block foundation, the walls are clad in siding and the brick chimney is located on the north roof hip. The front façade, facing east, has an off-center entrance flanked by two pairs of windows. A modern wood deck with flat roof and simple railings has been built at the single-leaf front entrance door, which has been replaced. Once incorporated under the hipped roof, an open-sided car port has been enclosed and converted to additional living space. A sliding door and widows have been added at the enclosure. Many of the original 2/2 double-hung windows remain, and many have wood storm windows. At the front façade, the windows are accented with open board and batten shutters. Through the alterations and additions, this modest box ranch has lost significant integrity.

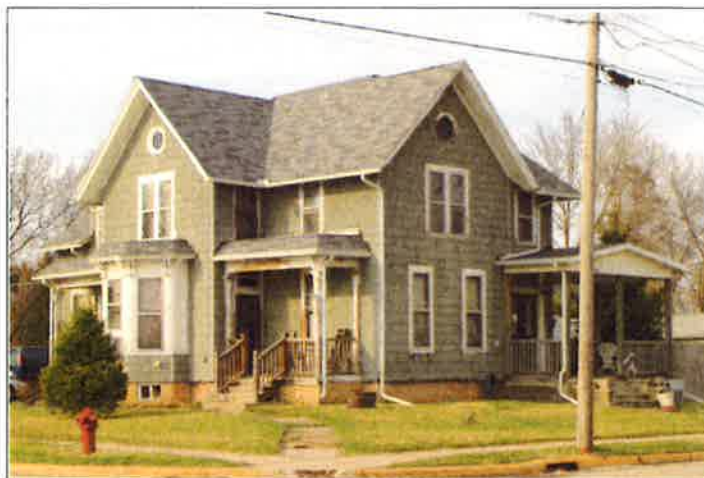
Photo: 206\_E\_Lincoln\_Ave\_SURVEY\_Photo.tif

Address: 206 E Lincoln PIN: 05-26-431-007  
 Building Names:  
 Important Dates:  
 Historic Function: Residence  
 Current Function: Residence  
 Color Code Criteria: Orange  
 Outbuildings  
 Number: 1 Any Significant:   
 Architectural Style: Italianate  
 Property Type: Residential  
 Approximate Age: 1870-1879  
 Condition: Fair  
 Potential for Integrity?

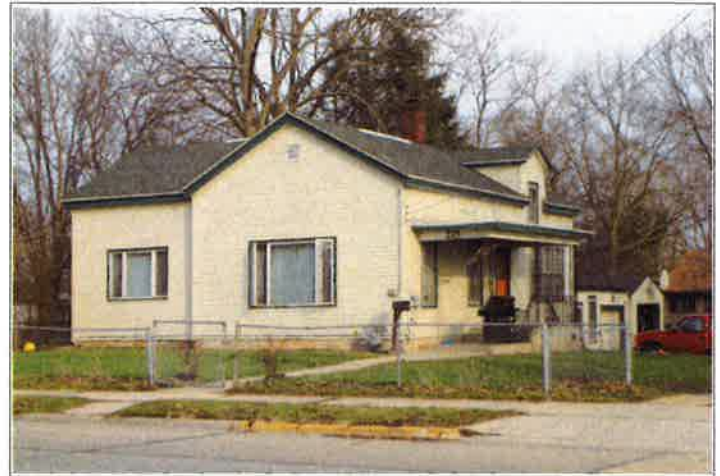
Photo: 215\_E\_Lincoln\_Ave\_SURVEY\_Photo.tif

Address: 215 E Lincoln PIN: 05-26-434-022  
 Building Names:  
 Important Dates:  
 Historic Function: Residence  
 Current Function: Residence  
 Color Code Criteria: Yellow  
 Outbuildings  
 Number: 0 Any Significant:   
 Architectural Style: Greek Revival  
 Property Type: Residential  
 Approximate Age: 1850-1859  
 Condition: Heavily Altered  
 Potential for Integrity?

This single family house is one-and-one-half stories. The principle massing is side gabled with a gabled rear addition forming an L shaped plan. A later gabled roof addition and garage extend south down the sloping site. The house and rear wing are set on a foundation of brick and are clad in vinyl siding. The principal façade, facing west, has a centrally located entrance with two single 1/1 double hung windows to the north and a grouping of three double hung windows to the south. The single-leaf entrance is located at a concrete stoop with simple iron railings and supports for a flat porch roof. A gabled wall dormer is placed slightly off center on the west façade. Two modern picture window and casement assemblies have been installed at the north gable and elevation of the main massing and wing. The one story gable roof addition to the south has single 1/1 double-hung windows several bays long and appears to be one room deep. The building's small size, massing, orientation and materials indicate that the primary side gabled section had a one room deep plan with a rear kitchen wing. This house represents an early settlement structure or worker's cottage that has been updated and modernized over time.

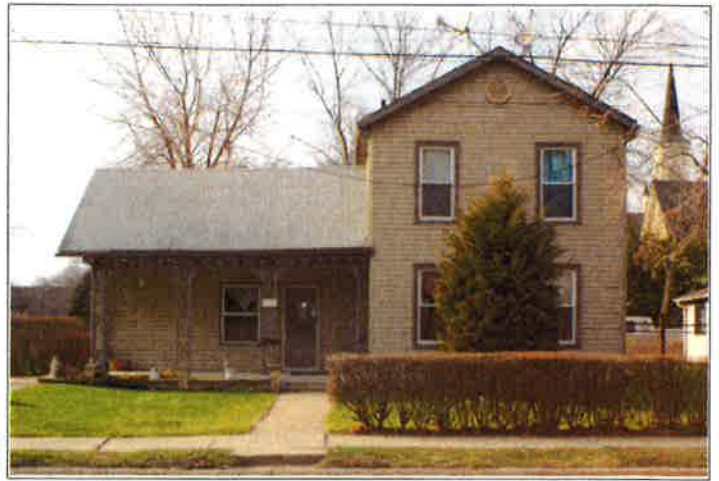
Photo: 218\_E\_Lincoln\_Ave\_SURVEY\_Photo.tif

Address: 218 E Lincoln PIN: 05-26-431-008  
 Building Names:  
 Important Dates:  
 Historic Function: Residence  
 Current Function: Residence  
 Color Code Criteria: Yellow  
 Outbuildings  
 Number: 0 Any Significant:   
 Architectural Style: Greek Revival  
 Property Type: Residential  
 Approximate Age: 1850-1859  
 Condition: Good/Excellent  
 Potential for Integrity?

The single family home is two stories with upright and wing massing. The upright section has a front facing gable and is two bays wide and deep. The side-gabled wing spans two bays wide and two bay deep with a gabled roof addition at the rear elevation. The foundation is not visible and the walls are clad in vinyl siding. At the front gable façade, facing south, the windows are centered. At the wing, the side gable roof overhangs a recessed porch with a low concrete slab. Unoriginal saw-cut lattice posts, brackets, and trim decorate the porch. Under the porch, the replacement entrance door is paneled with a small lite. Immediately adjacent to the door is a small 1/1 double hung window. All original windows have been replaced with 1/1 double hung windows, and the wood frames have altered. The size and arrangement of features suggest a settlement dwelling, but many alterations and missing elements have caused this structure to lose significant integrity.

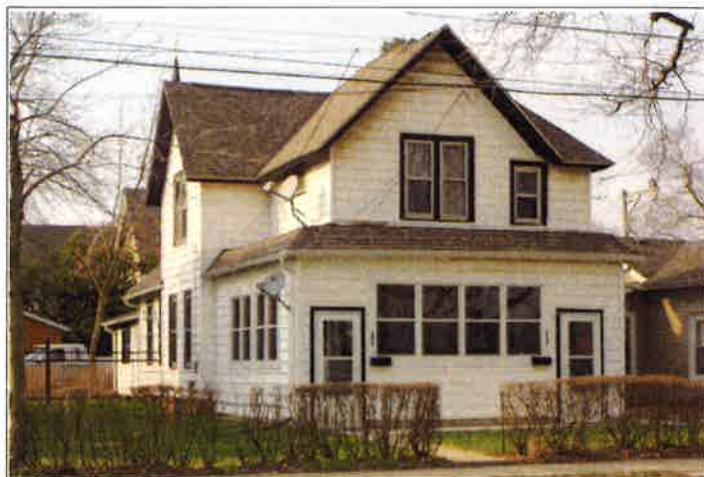
Photo: 220\_E\_Lincoln\_Ave\_SURVEY\_Photo.tif

Address: 220 E Lincoln PIN: 05-26-431-009  
 Building Names:  
 Important Dates:  
 Historic Function: Residence  
 Current Function: Apartments  
 Color Code Criteria: Yellow  
 Outbuildings  
 Number: 1 Any Significant:   
 Architectural Style: Queen Anne  
 Property Type: Residential  
 Approximate Age: 1890-1899  
 Condition: Good  
 Potential for Integrity?
