Property Information

Address: 223 E Lincoln PIN: 05-26-434-021
 Building Names: Colonel Joel Walker Residence
 Important Dates: 1841 (construction date)
 Historic Function: Residence
 Current Function: Residence
 Color Code Criteria: Red
 Outbuildings
 Number: 1 Any Significant:
 Architectural Style: Greek Revival
 Property Type: Residential
 Approximate Age: 1840-1849
 Condition: Good
 Potential for Integrity?

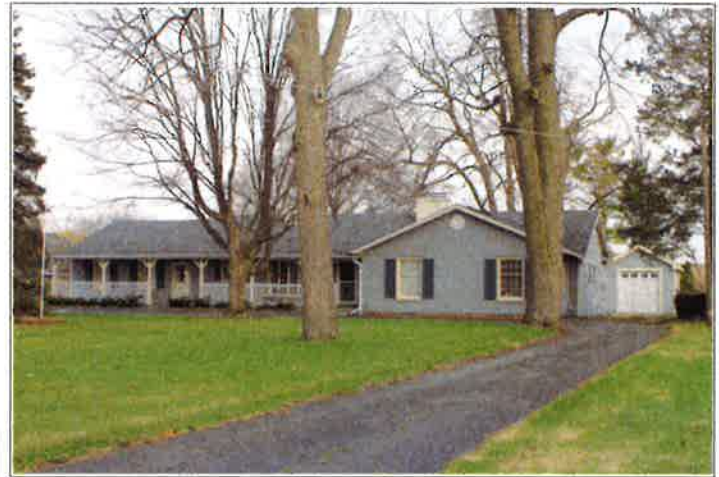
Photo: 505_E_Lincoln_Ave_SURVEY_Photo.tif

Address: 505 E Lincoln PIN: 05-25-301-006
 Building Names:
 Important Dates:
 Historic Function: Residence
 Current Function: Residence
 Color Code Criteria: Orange
 Outbuildings
 Number: 0 Any Significant:
 Architectural Style: Mid-Century
 Property Type: Residential
 Approximate Age: 1950-1959
 Condition: Good/Excellent
 Potential for Integrity?

The sprawling Ranch style single family home is one story with an "L" shaped plan, gabled roof and boxed eaves. Set on a concrete foundation, the walls are clad in siding and painted brick veneer. A brick chimney is centralized in the at the gable junction. The front façade is asymmetrical with a broad brick front gable and long side gabled wing. Two 8/12 double-hung windows are evenly spaced on the front gable. Spanning the entire length of the side wing is a recessed porch with a shed roof extension supported by square posts and stylized brackets with a simple balustrade. The main entrance, located at the inside corner, has a single-leaf door and one sidelite. Adjacent to the front door is a wide, shallow window bay with tall, narrow, multi-lite casements. An secondary entrance door, located further down the wing, has a multi-lite top with cross-buck paneling below. Other windows are short multi-lite casements or 6/6 double-hung windows with faux shutters. At the southwest corner of the property there is a front gabled one car garage clad in siding. The massing and plain details have been largely maintained, giving this modest Ranch home excellent integrity.

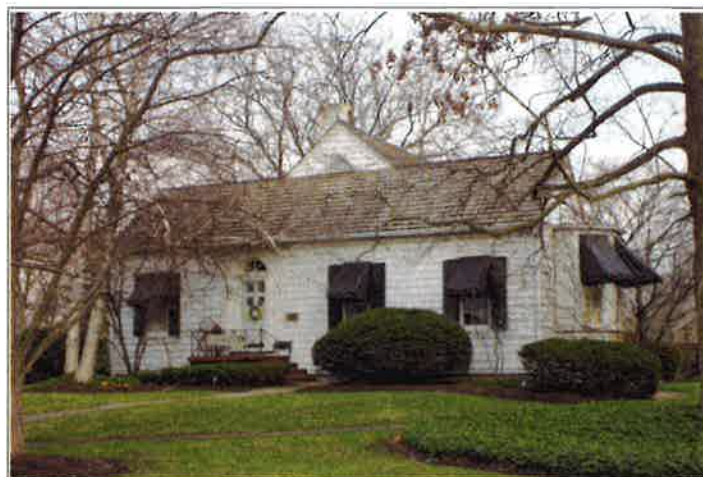
Photo: 509_E_Lincoln_Ave_SURVEY_Photo.tif

Address: 509 E Lincoln PIN: 05-25-160-001
 Building Names:
 Important Dates:
 Historic Function: Residence
 Current Function: Residence
 Color Code Criteria: Orange
 Outbuildings
 Number: 1 Any Significant:
 Architectural Style: Cape Cod
 Property Type: Residential
 Approximate Age: 1950-1959
 Condition: Good/Excellent
 Potential for Integrity?

This charming, mid-century Colonial Revival cottage is one-and-one-half stories with a "T" shaped plan and steeply pitched gabled roof massing. Set on a concrete block foundation, the walls are clad in siding and the roof is covered in wood shingles. A brick chimney is centralized in the at the gable junction. The front section is composed of a one story side gabled section with an evenly spaced four bay window and door layout on the front facade. The 6/6 double-hung windows are original with shaped wood frames and shutters. The front door assembly is located at a concrete stoop with simple X-braced iron railings. The single-leaf door is paneled with 4 lites and a half-round fan light above. The assembly is accented with fluted pilasters and framing, and a keystone. At the east and west gable ends are identical window bays with low hipped roofs and tall, narrow multi-lite casement windows. Situated behind and perpendicular to the front section is a larger one-and-one-half story gabled section. The height difference forms a small front facing gable. At the broad gable roof, there are single and double shed roof dormers. The other windows along this section are irregularly spaced. At the rear elevation, facing...

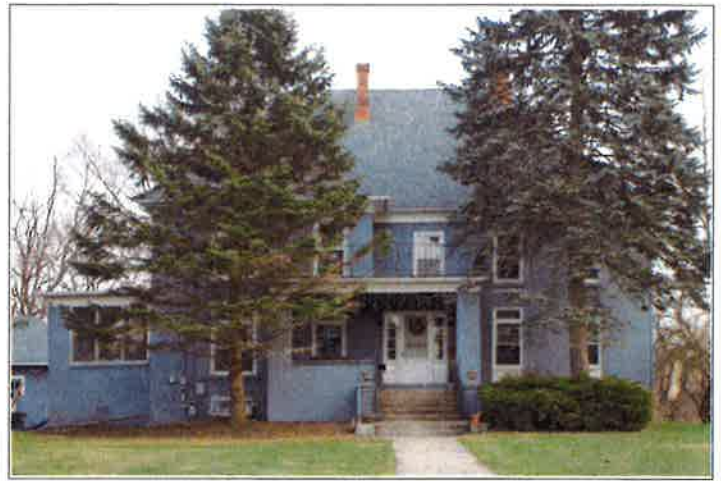
Photo: 519_E_Lincoln_Ave_SURVEY_Photo.tif

Address: 519 E Lincoln PIN: 05-25-160-002
 Building Names: Olney Residence
 Important Dates:
 Historic Function: Residence
 Current Function: Residence
 Color Code Criteria: Orange
 Outbuildings
 Number: 1 Any Significant:
 Architectural Style: None
 Property Type: Residential
 Approximate Age: 1900-1909
 Condition: Good/Excellent
 Potential for Integrity?

The single-family brick home is two stories with a tall, steeply pitched hipped roof, and rectangular massing. The original hipped roof Italianate structure is located on the west section, and had a plan approximately 3 bays wide by two bays deep. This was added onto at the east elevation, altering the footprint and roof. At the original section, the first floor is raised on a parged masonry foundation and the brick, laid in a running bond, has been painted. Original window openings on the west elevation have painted stone sills and smooth stone lintels. No original windows survive. At the front elevation, facing north, two tall windows at the first floor and three above appear to have original locations, but have been altered. The large, two story brick addition to the east added two additional bays and projects out from the original section. The roof was enlarged to unite the two sections and its tall, oversized chateausque style gives the home a grandiose, albeit mismatched, appearance. Between the two sections, a one story brick porch was added at the entrance. The original entrance door location was built-out to align with the new addition. The current door is a single-leaf with sidelights. The porch's flat roof is supported by...

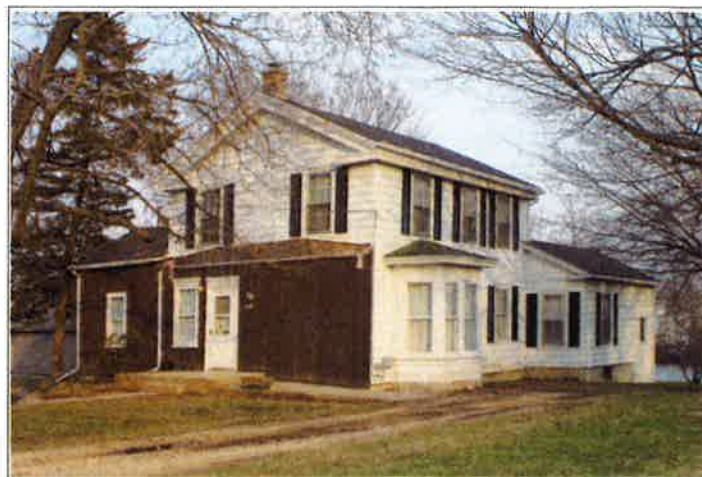
Photo: 531_E_Lincoln_Ave_SURVEY_Photo.tif

Address: 531 E Lincoln PIN: 05-25-160-003
 Building Names:
 Important Dates:
 Historic Function: Residence
 Current Function: Residence
 Color Code Criteria: Yellow
 Outbuildings
 Number: 1 Any Significant:
 Architectural Style: Greek Revival
 Property Type: Residential
 Approximate Age: 1860-1869
 Condition: Good
 Potential for Integrity?

The Greek Revival, single family home is two stories with a low front gable roof and rectangular massing. The first floor is raised on a parged masonry foundation, the walls are clad in siding, and the internal brick chimney is located at the front gable end. An original one story rear kitchen wing with gabled roof extends south. At the northeast corner, a one story saltbox addition covers the entire east elevation. The front gabled massing, facing north, is two bays wide by three bays deep and there are remnants of cornice returns. The north elevation's first floor and side addition are clad in vertical boards. The front door is located to one side at a low concrete stoop. Though not original, the one-lite paneled door is Victorian. This layout, including the kitchen wing, suggests an extended side hall floor plan. At the west elevation, a three-sided window bay has replaced an original window opening. The original window openings clad frames and faux shutters, but many of the original 6/6 and later 1/1 double hung windows remain. The size, height and arrangement of features suggest that this was a middle-class settlement dwelling. However, many alterations have compromised the building's integrity.

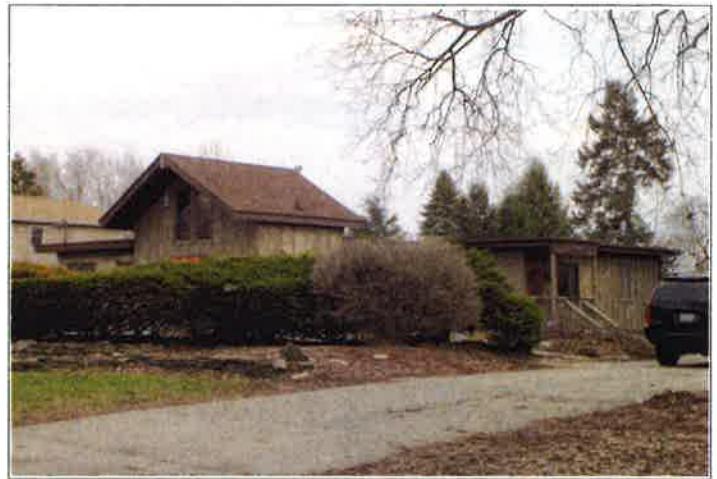
Photo: 601_E_Lincoln_Ave_SURVEY_Photo.tif

Address: 601 E Lincoln PIN: 05-25-160-004
 Building Names:
 Important Dates:
 Historic Function: Residence
 Current Function: Residence
 Color Code Criteria: Blue
 Outbuildings
 Number: 1 Any Significant:
 Architectural Style: Modern
 Property Type: Residential
 Approximate Age: 1970-1979
 Condition: Good/Excellent
 Potential for Integrity?

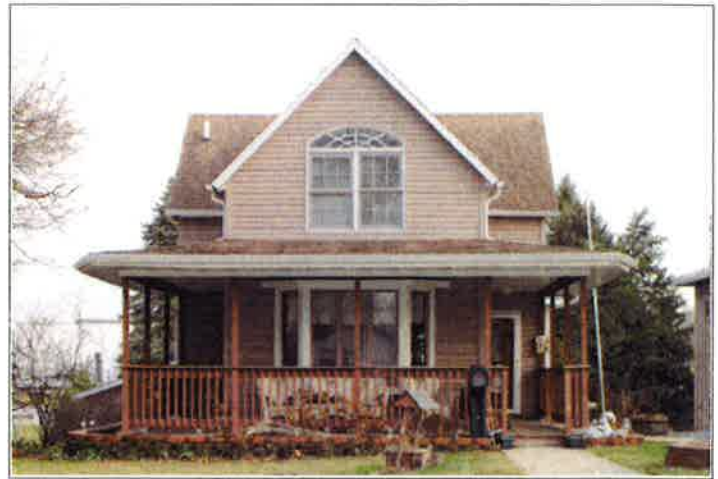
Photo: 613_E_Lincoln_Ave_SURVEY_Photo.tif

Address: 613 E Lincoln PIN: 05-25-160-005
 Building Names:
 Important Dates:
 Historic Function: Residence
 Current Function: Residence
 Color Code Criteria: None
 Outbuildings
 Number: 1 Any Significant:
 Architectural Style: Queen Anne
 Property Type: Residential
 Approximate Age: 1870-1879
 Condition: Heavily Altered
 Potential for Integrity?

The single family dwelling is two stories with a steeply pitched cross-gabled roof and "T" shaped plan. The walls are clad in replacement siding. The primary façade, facing north, is symmetrical with a prominent front gable and centered window openings. A large wood porch with a hipped roof wraps around the front gable wing and the main entrance is located at the west elevation inside corner. A large, two story wing at the rear elevation has a low pitched gable roof. Window openings are centered under the side gables. All original window openings have been altered, and no original windows remain. Though the building is believed to have been constructed in the 19th century and likely had a Queen Anne style. However, little to no original fabric remains and the home's integrity has been lost.

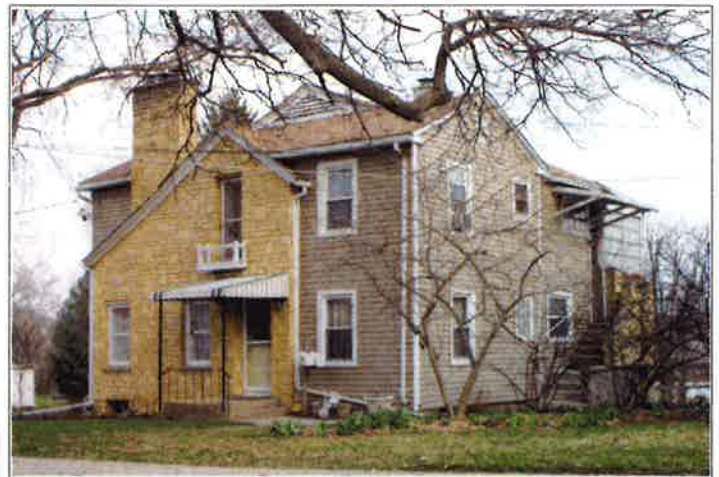
Photo: 621_E_Lincoln_Ave_SURVEY_Photo.tif

Address: 621 E Lincoln PIN: 05-25-160-006
 Building Names:
 Important Dates:
 Historic Function: Residence
 Current Function: Apartments
 Color Code Criteria: None
 Outbuildings
 Number: 0 Any Significant:
 Architectural Style: None
 Property Type: Residential
 Approximate Age: 1880-1889
 Condition: Good
 Potential for Integrity?

The single family dwelling is two stories with a low pitched cross-gabled roof and "T" shaped plan. The original 19th century side gabled I-house structure appears to have been modified and enlarged in the 20th century to incorporate Period Revival features. The walls are clad in replacement siding and stone veneer. The primary façade, facing north, is asymmetrical with a prominent, uneven stone veneered gable on the side gabled massing. A large stone chimney is located next to the front gable, and a two story gabled wing extends to the south. A two story rounded bay and enclosed porch are also located on the south elevation. The primary entrance, on the north elevation, is located off a low concrete stoop with simple iron railings and posts support a metal awning. The single-leaf front door has been replaced. Above, a multi-lite door leads out to a wood Juliet balcony. Two first floor windows at the front elevation have stone sills and 6/6 double-hung wood windows while the others have been replaced and their frames clad. A large window bay clad in stone was added to the east elevation and has 6/6 double-hung wood windows. Other replaced windows are centered on the gable...

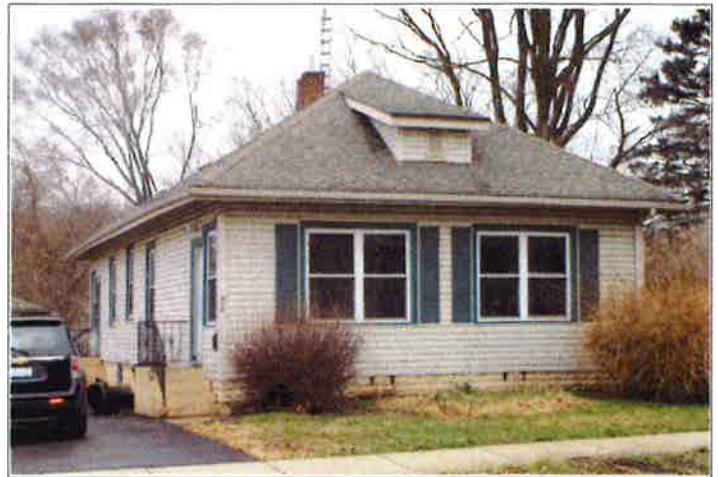
Photo: 210_E_Hurlbut_Ave_SURVEY_Photo.tif

Address: 210 E Hurlbut PIN: 05-26-287-008
 Building Names:
 Important Dates:
 Historic Function: Residence
 Current Function: Residence
 Color Code Criteria: Yellow
 Outbuildings
 Number: 0 Any Significant:
 Architectural Style: Craftsman
 Property Type: Residential
 Approximate Age: 1910-1919
 Condition: Good
 Potential for Integrity?

The one story frame Bungalow has a rectangular footprint and a hipped roof with small front & rear shed dormers. The first floor is raised on a rock-faced concrete block foundation. The front elevation is symmetrical; the full-width front porch has been enclosed with two pairs of 1/1 vinyl windows with faux shutters. All original windows have been replaced with 1/1 vinyl windows. On the west elevation, concrete stoops with metal railings give access to the front and rear porches. The entire house has been re-clad in vinyl siding.

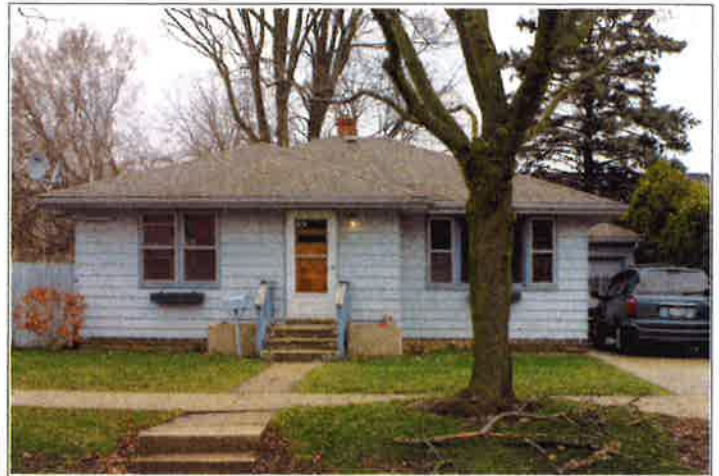
Photo: 216_E_Hurlbut_Ave_SURVEY_Photo.tif

Address: 216 E Hurlbut PIN: 05-26-287-009
 Building Names:
 Important Dates:
 Historic Function: Residence
 Current Function: Residence
 Color Code Criteria: Orange
 Outbuildings
 Number: 0 Any Significant:
 Architectural Style: Mid-Century
 Property Type: Residential
 Approximate Age: 1960-1969
 Condition: Good
 Potential for Integrity?

The box ranch, single-family frame home is one story with an asymmetric plan, hipped roof and boxed eaves. The first floor is raised on a rock-faced concrete block foundation and clad in wide siding. The front façade has an off-set footprint for the sleeping & living areas. While the entrance is centered between the two, the living room has a large picture window and the bedroom has a ganged pair of 1/1 windows. Other windows are typically single 1/1 double-hungs. Set back at the northeast corner of the house is a one-car attached garage. The front and side entrances have original slab wood doors with lites. The front stoop is modern concrete with wood railings.

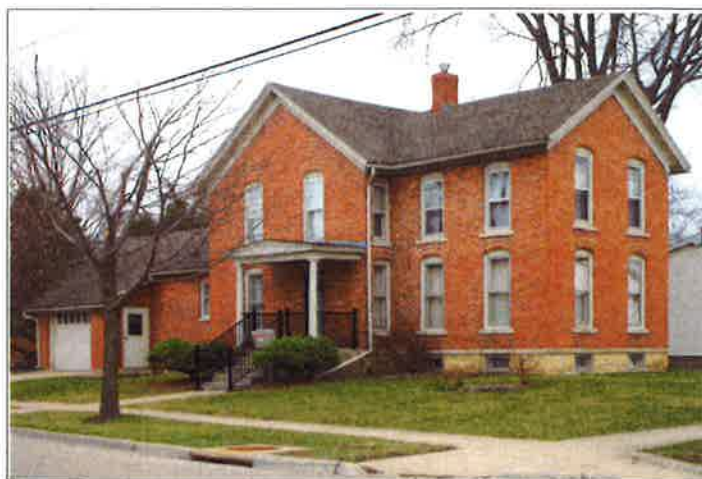
Photo: 17_E_Hurlbut_Ave_SURVEY_Photo_PARSONAGE.tif

Address: 217 E Hurlbut PIN: 05-26-431-012
 Building Names: Holy Trinity Parsonage
 Important Dates:
 Historic Function: Residence
 Current Function: Residence
 Color Code Criteria: Orange
 Outbuildings
 Number: 0 Any Significant:
 Architectural Style: Queen Anne
 Property Type: Residential
 Approximate Age: 1880-1889
 Condition: Good/Excellent
 Potential for Integrity?

The Italianate, single-family brick house is two stories with front-facing T-gable and wing massing and a tall, steeply pitched roof. The first floor is raised on a fieldstone foundation of local limestone with a dressed-stone water table. The main entrance is currently located on the north façade, but it appears that original door openings in the southwest corner have been bricked up or converted to windows. Ghosts on the brick indicate there was once a one-story porch at the original entrance. The west and north gabled elevations have symmetrical façades of two window bays. Set back two window bays from the west, the north-south cross-gabled section extends one window bay wider than the west wing. At the south façade, a full-height tower one window bay deep accesses each floor and the attic with an entrance at grade level. The rear wing, extending to the east, is one story tall with a gabled roof. A modern one-car garage of brick with a concrete foundation was attached east of the rear wing, continuing the same roofline. Built early in the Italianate period, the remaining details are simple. The tall, narrow 1/1 windows have rectangular sash with segmental-arch brick heads and stone sills, and small rectangular 3-lite basement windows pierce the limestone foundation. At the north façade's...

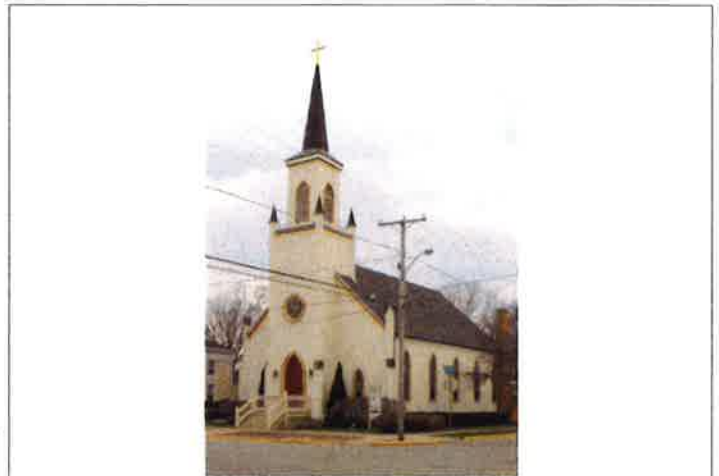
Photo: 217_E_Hurlbut_Ave_SURVEY_Photo_CHURCH.tif

Address: 217 E Hurlbut PIN: 05-26-431-013
 Building Names: Holy Trinity Episcopal Church
 Important Dates: 1856
 Historic Function: Church
 Current Function: Church
 Color Code Criteria: Red
 Outbuildings
 Number: 0 Any Significant:
 Architectural Style: Gothic Revival
 Property Type: Institutional
 Approximate Age: 1850-1859
 Condition: Good/Excellent
 Potential for Integrity?

The Carpenter Gothic church has frame construction, a steeply pitched gable roof, central tower and rectangular massing. The building is clad in vertical board-and-batten siding with wide cornice boards at the roofline. A one-and-one-half story sanctuary level is raised on a low foundation of rubble limestone, and the steepled tower rises three stories. The front gabled façade, facing west, is dominated by an engaged central tower with a square footprint and shallow diagonal (French) buttresses. Above the second floor roofline, the corner buttresses are topped with steepled pinnacles and the tower parapet is castellated. A third floor belfry with Gothic arch louvers is set back inside the parapets and topped with a double-pitched steeple and cross finial. The main entrance is centered at the tower's first floor. A pair of large batten doors sits in a Gothic arch opening, with small, pointed arch art glass windows at each side on the main façade. At the main entrance, a wood stoop is decorated with saw-tooth shingles, flat, jig-saw cut balusters and newels in Gothic tracery designs. Above the tower entrance is a small rose window set with wood tracery and art glass. The main, rectangular massing of the sanctuary is also set with diagonal corner buttresses which are capped with gabled pinnacles and wood shingles.

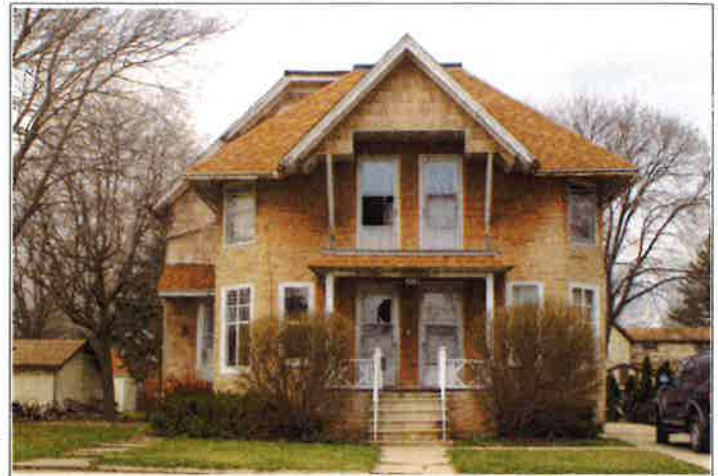
Photo: 310_E_Hurlbut_Ave_SURVEY_Photo.tif

Address: 310 E Hurlbut PIN: 05-26-288-006
 Building Names:
 Important Dates:
 Historic Function: Apartments
 Current Function: Apartment
 Color Code Criteria: Yellow
 Outbuildings
 Number: 1 Any Significant:
 Architectural Style: Queen Anne
 Property Type: Residential
 Approximate Age: 1890-1899
 Condition: Fair
 Potential for Integrity?

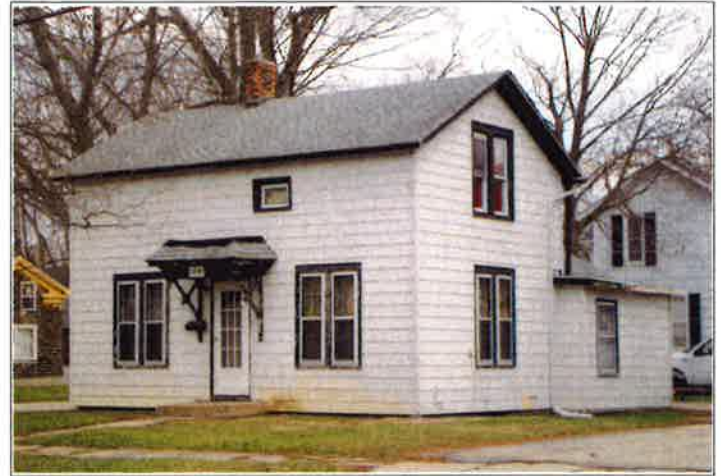
Photo: 319_E_Hurlbut_Ave_SURVEY_Photo.tif

Address: 319 E Hurlbut PIN: 05-26-291-001
 Building Names:
 Important Dates:
 Historic Function: Residence
 Current Function: Residence
 Color Code Criteria: Yellow
 Outbuildings
 Number: 1 Any Significant:
 Architectural Style: Greek Revival
 Property Type: Residential
 Approximate Age: 1860-1869
 Condition: Fair
 Potential for Integrity?

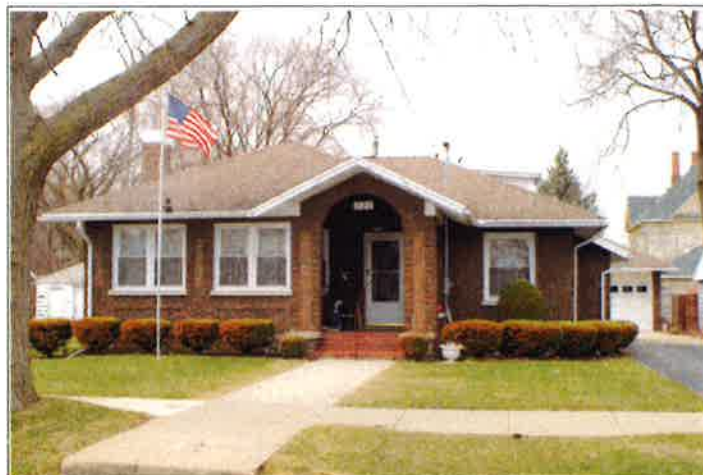
Photo: 320_E_Hurlbut_Ave_SURVEY_Photo.tif

Address: 320 E Hurlbut PIN: 05-26-288-007
 Building Names:
 Important Dates:
 Historic Function: Residence
 Current Function: Residence
 Color Code Criteria: Orange
 Outbuildings
 Number: 1 Any Significant:
 Architectural Style: Craftsman
 Property Type: Residential
 Approximate Age: 1920-1929
 Condition: Good/Excellent
 Potential for Integrity?

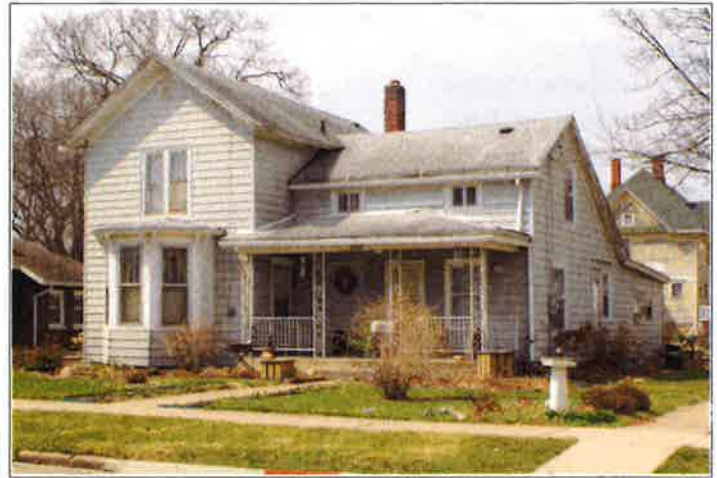
Photo: 322_E_Hurlbut_Ave_SURVEY_Photo.tif

Address: 322 E Hurlbut PIN: 05-26-288-008
 Building Names:
 Important Dates:
 Historic Function: Residence
 Current Function: Residence
 Color Code Criteria: Yellow
 Outbuildings
 Number: 1 Any Significant:
 Architectural Style: Queen Anne
 Property Type: Residential
 Approximate Age: 1880-1889
 Condition: Fair
 Potential for Integrity?

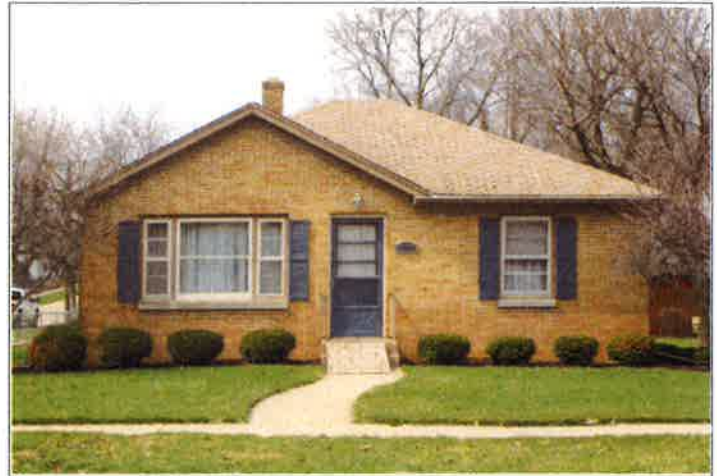
Photo: 402_E_Hurlbut_Ave_SURVEY_Photo.tif

Address: 402 E Hurlbut PIN: 05-26-289-006
 Building Names:
 Important Dates: 1955 (date of construction)
 Historic Function: Residence
 Current Function: Residence
 Color Code Criteria: Orange
 Outbuildings
 Number: 0 Any Significant:
 Architectural Style: Mid-Century
 Property Type: Residential
 Approximate Age: 1950-1959
 Condition: Excellent
 Potential for Integrity?

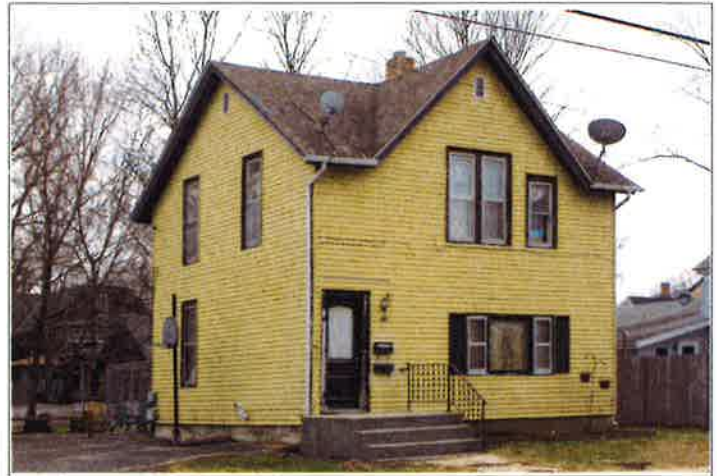
Photo: 409_E_Hurlbut_Ave_SURVEY_Photo.tif

Address: 409 E Hurlbut PIN: 05-25-159-001
 Building Names:
 Important Dates:
 Historic Function: Residence
 Current Function: Residence
 Color Code Criteria: Yellow
 Outbuildings
 Number: 0 Any Significant:
 Architectural Style: Gothic Revival
 Property Type: Residential
 Approximate Age: 1880-1889
 Condition: Fair
 Potential for Integrity?

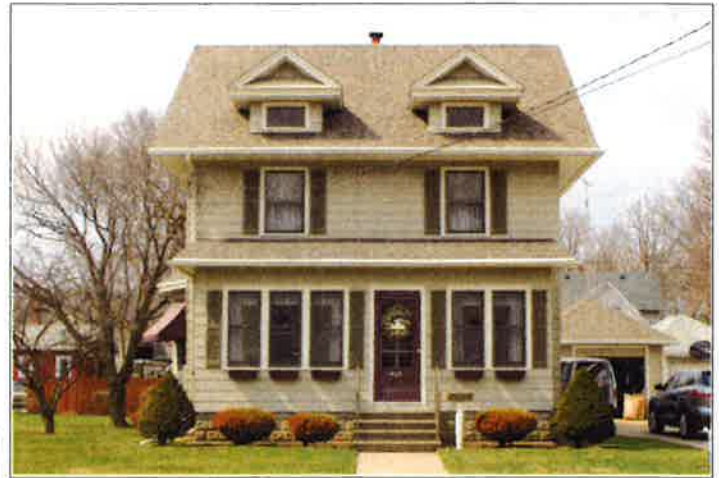
Photo: 410_E_Hurlbut_Ave_SURVEY_Photo.tif

Address: 410 E Hurlbut PIN: 05-26-289-007
 Building Names:
 Important Dates:
 Historic Function: Residence
 Current Function: Residence
 Color Code Criteria: Orange
 Outbuildings
 Number: 1 Any Significant:
 Architectural Style: Craftsman
 Property Type: Residential
 Approximate Age: 1920-1929
 Condition: Excellent
 Potential for Integrity?

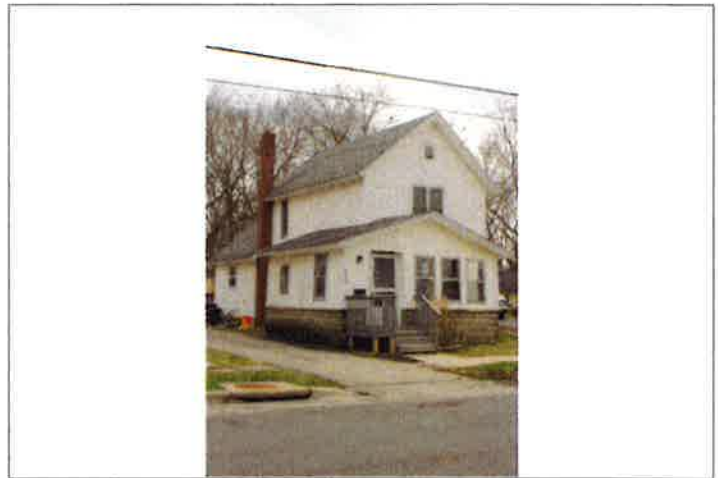
Photo: 413_E_Hurlbut_Ave_SURVEY_Photo.tif

Address: 413 E Hurlbut PIN: 05-25-159-003
 Building Names:
 Important Dates:
 Historic Function: Residence
 Current Function: Residence
 Color Code Criteria: Yellow
 Outbuildings
 Number: 1 Any Significant:
 Architectural Style: Queen Anne
 Property Type: Residential
 Approximate Age: 1890-1899
 Condition: Good
 Potential for Integrity?

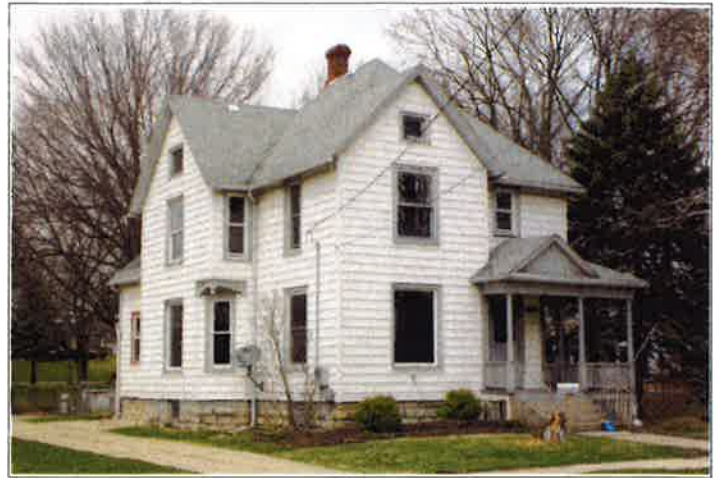
Photo: 416_E_Hurlbut_Ave_SURVEY_Photo.tif

Address: 416 E Hurlbut PIN: 05-26-289-008
 Building Names:
 Important Dates:
 Historic Function: Residence
 Current Function: Residence
 Color Code Criteria: Yellow
 Outbuildings
 Number: 1 Any Significant:
 Architectural Style: Queen Anne
 Property Type: Residential
 Approximate Age: 1890-1899
 Condition: Fair
 Potential for Integrity?

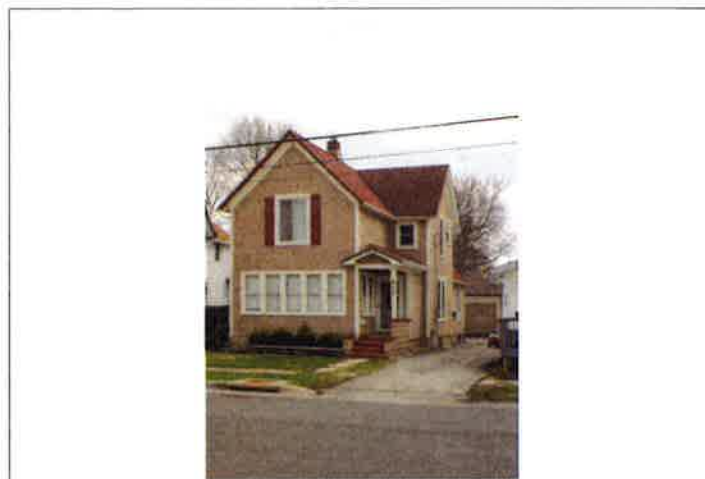
Photo: 417_E_Hurlbut_Ave_SURVEY_Photo.tif

Address: 417 E Hurlbut PIN: 05-25-159-004
 Building Names:
 Important Dates:
 Historic Function: Residence
 Current Function: Residence
 Color Code Criteria: Yellow
 Outbuildings
 Number: 1 Any Significant:
 Architectural Style: Queen Anne
 Property Type: Residential
 Approximate Age: 1900-1909
 Condition: Good/Excellent
 Potential for Integrity?

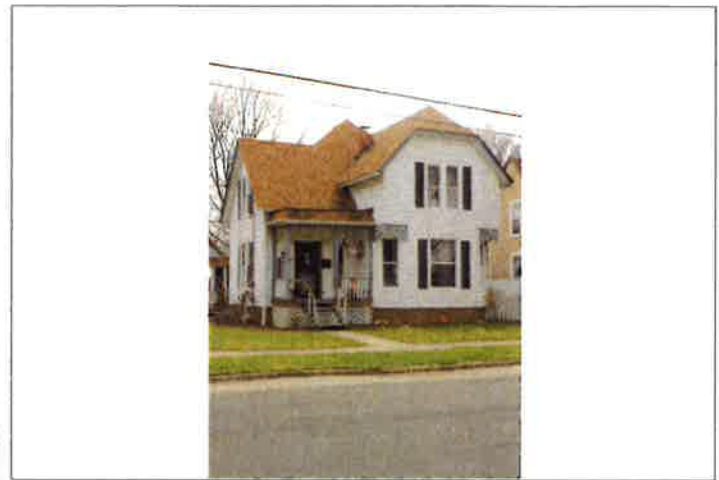
Photo: 421_E_Hurlbut_Ave_SURVEY_Photo.tif

Address: 421 E Hurlbut PIN: 05-25-159-005
 Building Names:
 Important Dates:
 Historic Function: Residence
 Current Function: Residence
 Color Code Criteria: Yellow
 Outbuildings
 Number: 0 Any Significant:
 Architectural Style: Queen Anne
 Property Type: Residential
 Approximate Age: 1900-1909
 Condition: Good
 Potential for Integrity?

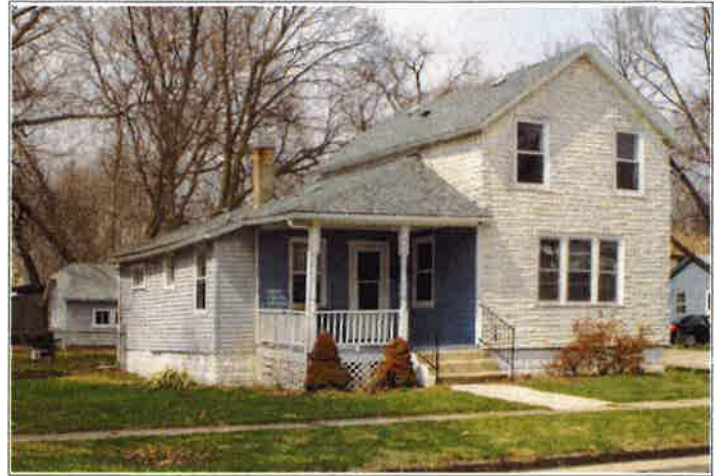
Photo: 424_E_Hurlbut_Ave_SURVEY_Photo.tif

Address: 424 E Hurlbut PIN: 05-25-157-001
 Building Names:
 Important Dates:
 Historic Function: Residence
 Current Function: Residence
 Color Code Criteria: None
 Outbuildings
 Number: 1 Any Significant:
 Architectural Style: Settlement
 Property Type: Residential
 Approximate Age: 1850-1859
 Condition: Good
 Potential for Integrity?

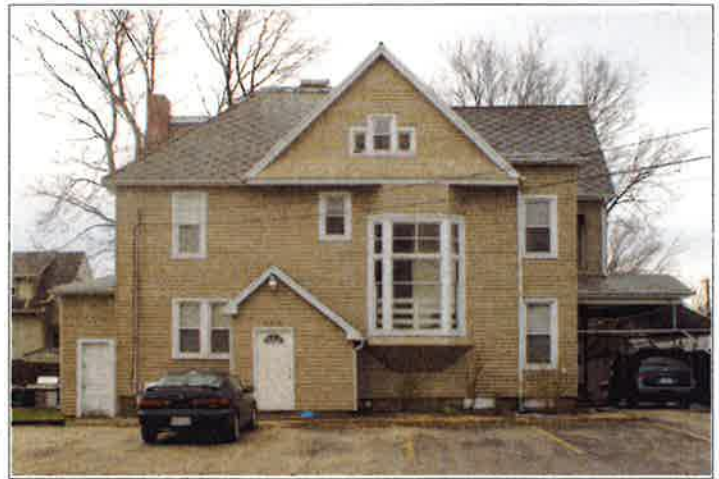
Photo: 115_E_Madison_St_SURVEY_Photo.tif

Address: 115 E Madison PIN: 05-26-427-005
 Building Names:
 Important Dates:
 Historic Function: Residence
 Current Function: Apartments
 Color Code Criteria: Yellow
 Outbuildings
 Number: 0 Any Significant:
 Architectural Style: Queen Anne
 Property Type: Residential
 Approximate Age: 1900-1909
 Condition: Good
 Potential for Integrity?

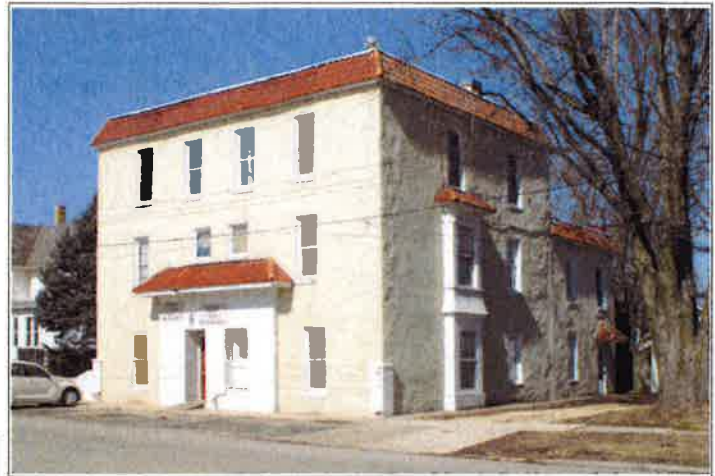
Photo: 120_E_Madison_St_SURVEY_Photo.tif

Address: 120 E Madison PIN:
 Building Names: Herrick and Wing Carriage Factory
 Important Dates: 1851 (date of construction)
 Historic Function: Carriage Factory
 Current Function: Apartments
 Color Code Criteria: Orange
 Outbuildings
 Number: 0 Any Significant:
 Architectural Style: Settlement
 Property Type: Residential
 Approximate Age: 1850-1859
 Condition: Fair
 Potential for Integrity?

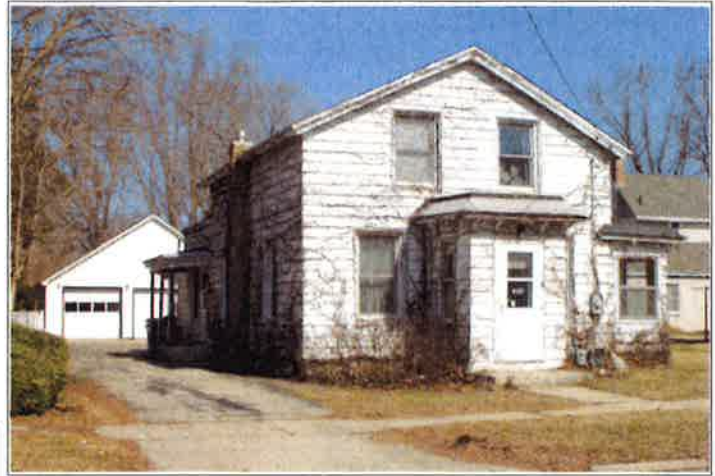
Photo: 214_E_Madison_St_SURVEY_Photo.tif

Address: 214 E Madison PIN: 05-26-282-006
 Building Names:
 Important Dates:
 Historic Function: Residence
 Current Function: Residence
 Color Code Criteria: Yellow
 Outbuildings
 Number: 1 Any Significant:
 Architectural Style: Settlement
 Property Type: Residential
 Approximate Age: 1850-1859
 Condition: Good
 Potential for Integrity?

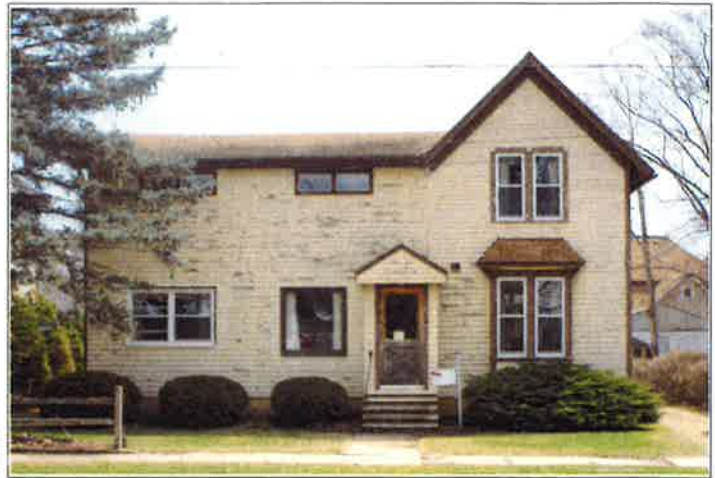
Photo: 315_E_Madison_St_SURVEY_Photo.tif

Address: 315 E Madison PIN: 05-26-288-004
 Building Names:
 Important Dates:
 Historic Function: Residence
 Current Function: Residence
 Color Code Criteria: Yellow
 Outbuildings
 Number: 1 Any Significant:
 Architectural Style: Queen Anne
 Property Type: Residential
 Approximate Age: 1880-1889
 Condition: Fair
 Potential for Integrity?

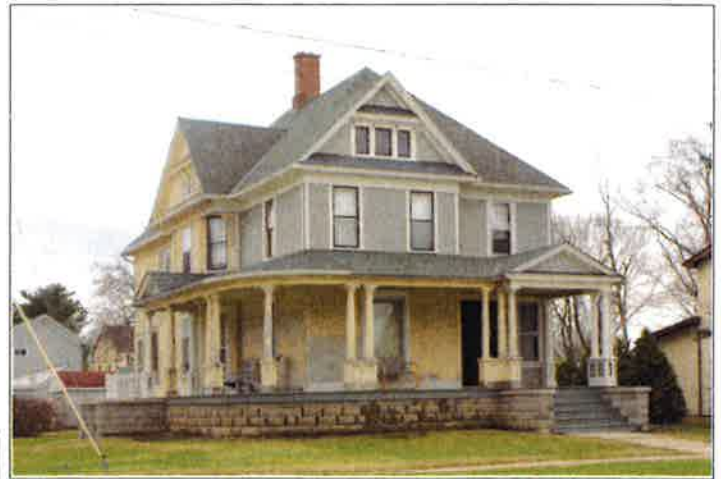
Photo: 321_E_Madison_St_SURVEY_Photo.tif

Address: 321 E Madison PIN: 05-26-288-004
 Building Names: Henry Haywood Residence
 Important Dates:
 Historic Function: Residence
 Current Function: Residence
 Color Code Criteria: Red
 Outbuildings
 Number: 1 Any Significant:
 Architectural Style: Queen Anne
 Property Type: Residential
 Approximate Age: 1890-1899
 Condition: Good
 Potential for Integrity?

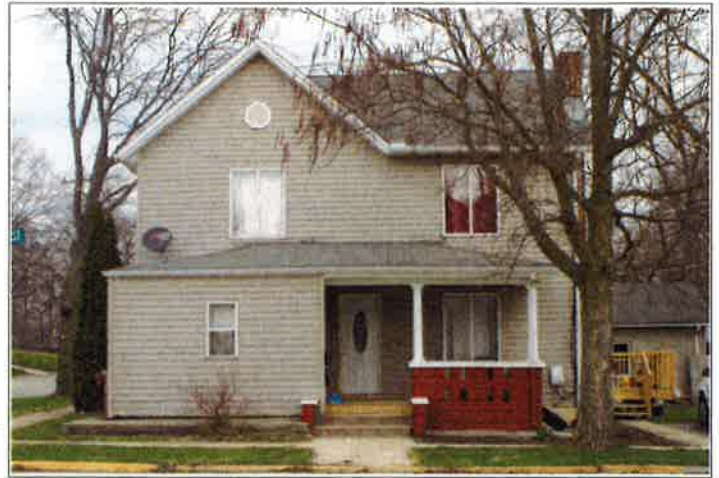
Photo: 401_E_Madison_St_SURVEY_Photo.tif

Address: 401 E Madison PIN: 05-26-289-001
 Building Names:
 Important Dates:
 Historic Function: Residence
 Current Function: Apartments
 Color Code Criteria: None
 Outbuildings
 Number: 1 Any Significant:
 Architectural Style: Queen Anne
 Property Type: Residential
 Approximate Age: 1910-1919
 Condition: Good
 Potential for Integrity?

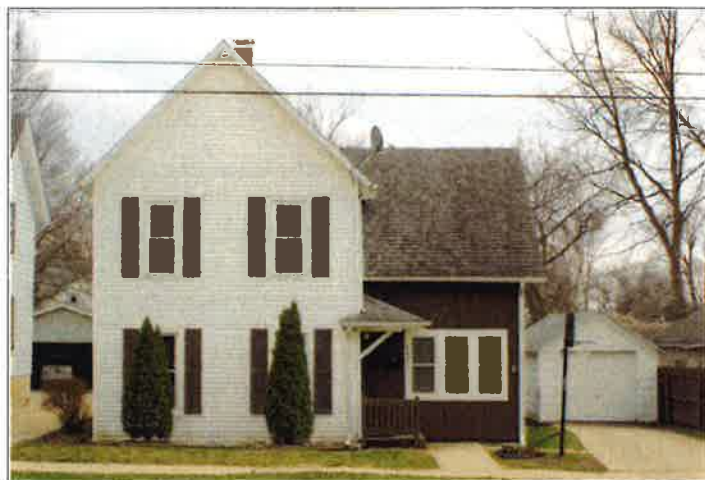
Photo: 403_E_Madison_St_SURVEY_Photo.tif

Address: 403 E Madison PIN: 05-26-289-002
 Building Names:
 Important Dates:
 Historic Function: Residence
 Current Function: Residence
 Color Code Criteria: Yellow
 Outbuildings
 Number: 1 Any Significant:
 Architectural Style: Queen Anne
 Property Type: Residential
 Approximate Age: 1890-1899
 Condition: Good
 Potential for Integrity?

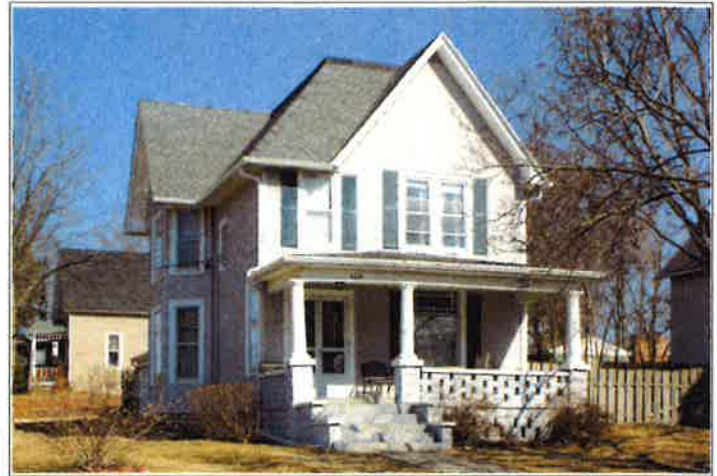
Photo: 404_E_Madison_St_SURVEY_Photo.tif

Address: 404 E Madison PIN: 05-26-284-007
 Building Names:
 Important Dates:
 Historic Function: Residence
 Current Function: Residence
 Color Code Criteria: Yellow
 Outbuildings
 Number: 0 Any Significant:
 Architectural Style: Queen Anne
 Property Type: Residential
 Approximate Age: 1890-1899
 Condition: Good/Excellent
 Potential for Integrity?

The Queen Anne, single-family frame house is two-and-one-half stories with a steeply pitched hipped roof and cross-gabled massing. The first floor is raised on a foundation of coursed rock-faced limestone and the exterior is clad in siding. At the primary elevation, facing south, there is a gable-front section with centered window openings and a full width front porch. The front has a rock-faced concrete block base and knee walls with a hipped roof. Squat turned columns sit on concrete block pedestals and additional blocks are also used as a baluster. The main entry is placed at the southwest corner, and the double-front doors are not original. Directly adjacent is a large landscape window with a multi-lite Queen Anne transom. The west elevation gable end is canted and the windows are centered with a large landscape window and transom at each floor. A small double-hung attic sash is placed high in the gable end. The east gable has centered pairs of windows placement and several other openings have decorative Queen Anne sashes. A one-and-one-half story gabled wing is located at the rear elevation. Typical windows are single, tall, 1/1 double-hungs with rectangular sash. Many of the original windows remain, but the frames...

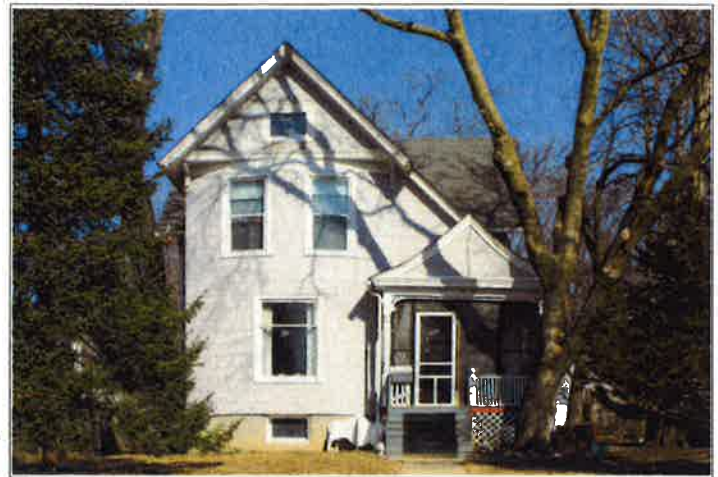
Photo: 410_E_Madison_St_SURVEY_Photo.tif

Address: 410 E Madison PIN: 05-26-284-008
 Building Names:
 Important Dates:
 Historic Function: Residence
 Current Function: Residence
 Color Code Criteria: Yellow
 Outbuildings
 Number: 1 Any Significant:
 Architectural Style: Queen Anne
 Property Type: Residential
 Approximate Age: 1880-1889
 Condition: Good/Excellent
 Potential for Integrity?

The Queen Anne, single-family frame house is two-and-one-half stories with a steeply pitched cross-gabled roof. The first floor is raised on a parged masonry foundation, the exterior is clad in asbestos siding, and a brick chimney is located at the west elevation. At the primary elevation, facing south, there is a gable-front section with centered window openings and a one-story front porch to the east side. The front gable has a bowed first and second floor with a bracketed, closed gable above. A large picture window with transom is at the first floor, two 1/1 double-hung windows are at the second floor and a small 1-lite window is placed at the attic level. The wood side porch has turned posts with decorative corner brackets and a flared, front gabled roof. The main front gable roof extends down to merge with the porch roof. The main entrance is obstructed by the screened front porch. The east and west elevation gable windows are typically centered. A one-and-one-half story gabled wing is located at the rear elevation and a recessed porch and the half walls have turned column supports. Typical windows are single, tall, 1/1 double-hungs with rectangular sash, many of which have been replaced. The frames have been clad and small...

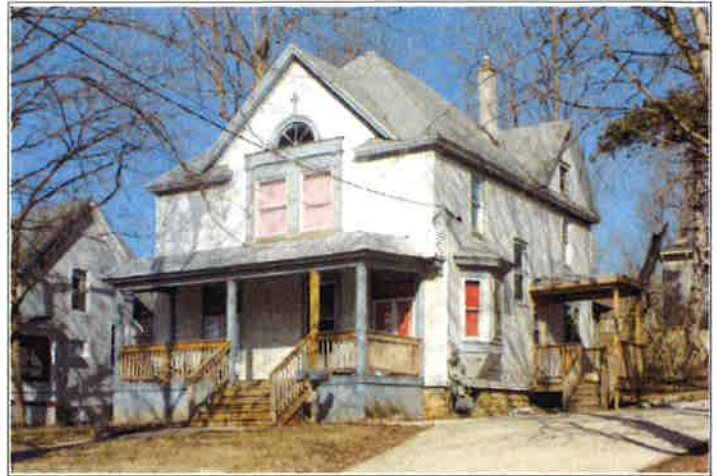
Photo: 414_E_Madison_St_SURVEY_Photo.tif

Address: 414 E Madison PIN: 05-26-284-009
 Building Names:
 Important Dates:
 Historic Function: Residence
 Current Function: Residence
 Color Code Criteria: Yellow
 Outbuildings
 Number: 0 Any Significant:
 Architectural Style: Queen Anne
 Property Type: Residential
 Approximate Age: 1900-1909
 Condition: Good
 Potential for Integrity?

The Queen Anne, single-family frame house is two-and-one-half stories with a steeply pitched hipped roof with lower cross gables and a prominent gabled wall dormer. The first floor is raised on a coursed rock-faced limestone foundation and the exterior is clad in siding. At the primary elevation, facing south, has an overhanging second floor with brackets and a one story full-width front porch. The short mansard roof is supported with square wood posts and has a simple wood railing and enclosed base. The original entrance door is paneled with a half lite. Two windows at the porch have decorative Queen Anne diamond-lite transoms with their lower sash replaced. Above the porch, a pair of windows is centered on the large front gabled dormer. The window pair is framed in simplified pilasters and topped with a half-round lunette and keystone. The dormer takes on the form of a pediment with short pented returns at the eaves. The east and west cross gables are closed at the third floor with a pent roof and the first floor at the west gable is canted with decorative brackets. Windows are placed symmetrically on the overall asymmetrical elements. Additional porches are found at the east and rear elevations. The single, tall, double-hung 1/1...

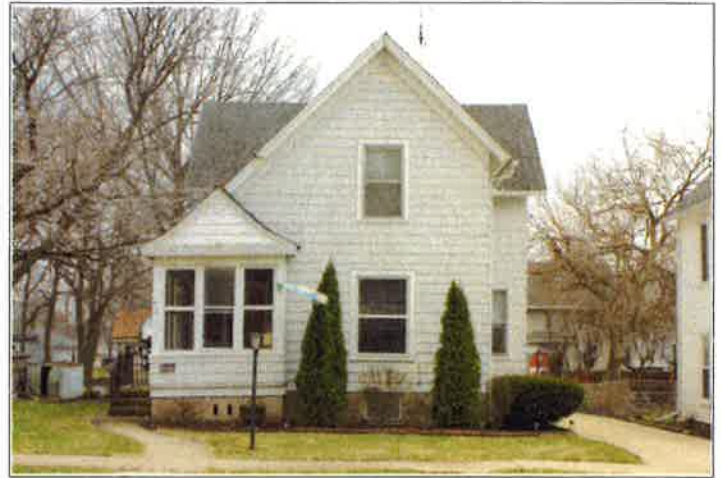
Photo: 415_E_Madison_St_SURVEY_Photo.tif

Address: 415 E Madison PIN: 05-26-289-003
 Building Names:
 Important Dates:
 Historic Function: Residence
 Current Function: Residence
 Color Code Criteria: Yellow
 Outbuildings
 Number: 1 Any Significant:
 Architectural Style: Queen Anne
 Property Type: Residential
 Approximate Age: 1900-1909
 Condition: Good
 Potential for Integrity?

The Queen Anne, single-family frame house is two stories with a steeply pitched cross-gabled roof. The first floor is raised on a parged limestone foundation, the exterior is clad in siding, and a brick chimney is centrally located. At the primary elevation, facing north, there is a gable-front section with centered window openings and a one-story front porch to the east side. A large 1/1 double-hung window is at the first floor, with a smaller 1/1 double-hung window at the second floor. The front porch is enclosed and lined with double-hung windows. It has a concrete block base punctured with small rectangular 1-lite windows and a flared, front gabled roof. The main front gable roof extends down to merge with the porch roof. The main entrance is obstructed by the front porch, which is accessed from the east side at a small concrete stoop. The east and west elevation gable windows are typically centered. A one story gabled wing is located at the rear elevation. Typical windows are single, tall, 1/1 double-hungs with rectangular sash, many of which have been replaced. Surviving details suggest that this house is a folk Victorian sub-type of the Queen Anne style, though many decorative elements have been altered.

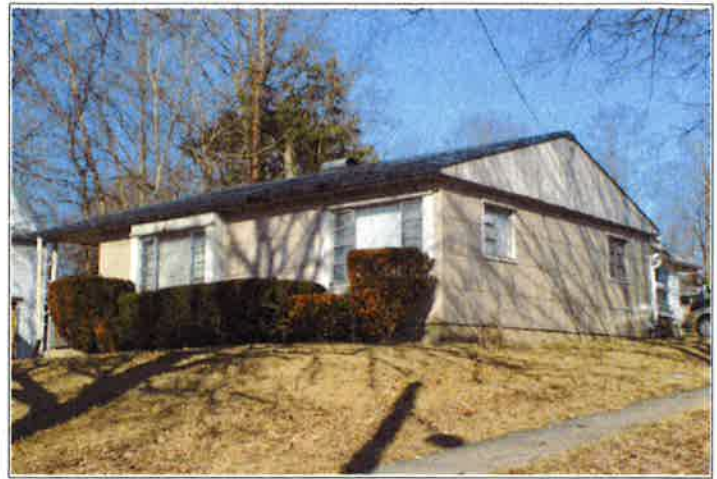
Photo: 420_E_Madison_St_SURVEY_Photo.tif

Address: 420 E Madison PIN: 05-26-284-010
 Building Names:
 Important Dates:
 Historic Function: Residence
 Current Function: Residence
 Color Code Criteria: Red
 Outbuildings
 Number: 0 Any Significant:
 Architectural Style: Lustron
 Property Type: Residential
 Approximate Age: 1940-1949
 Condition: Good
 Potential for Integrity?
